FACILITIES ASSESSMENT AND GROWTH PROJECTION REPORT

Horseshoe Bend

School District No. 73

Horseshoe Bend, Idaho
September 21, 2021

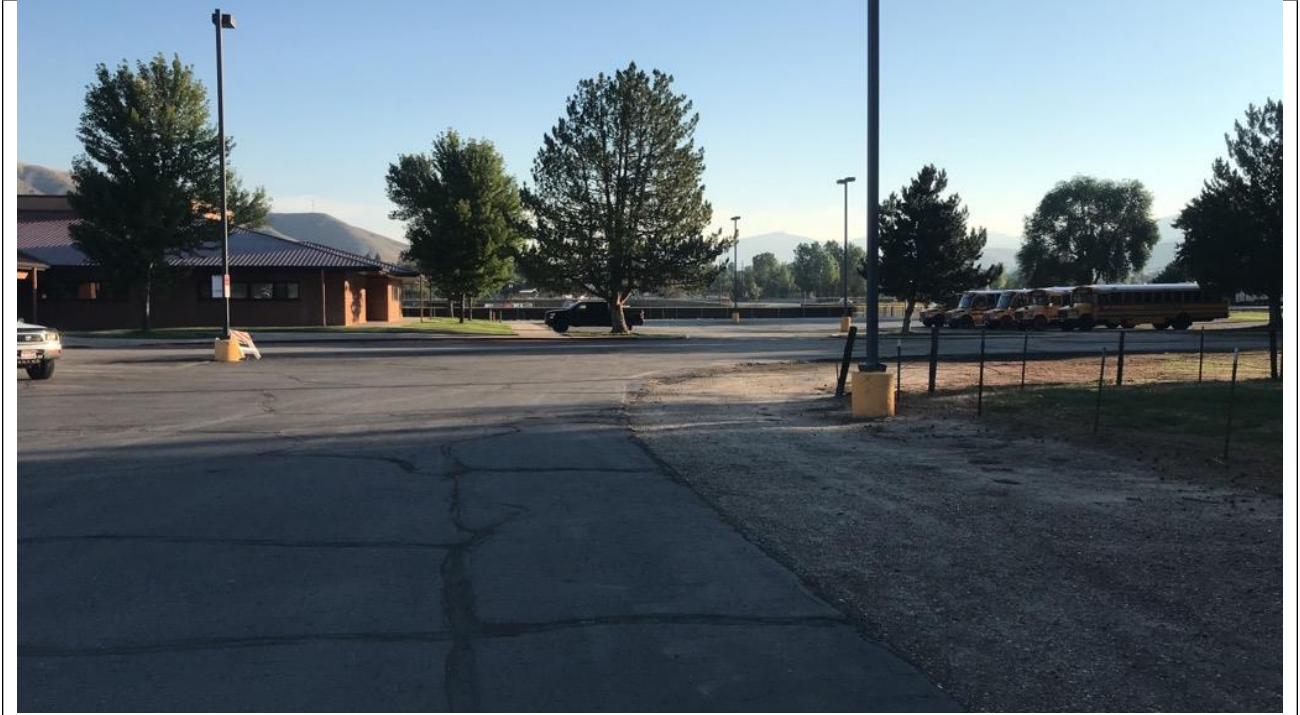
LOOKING NORTH / SITE LIGHTING IS GOOD

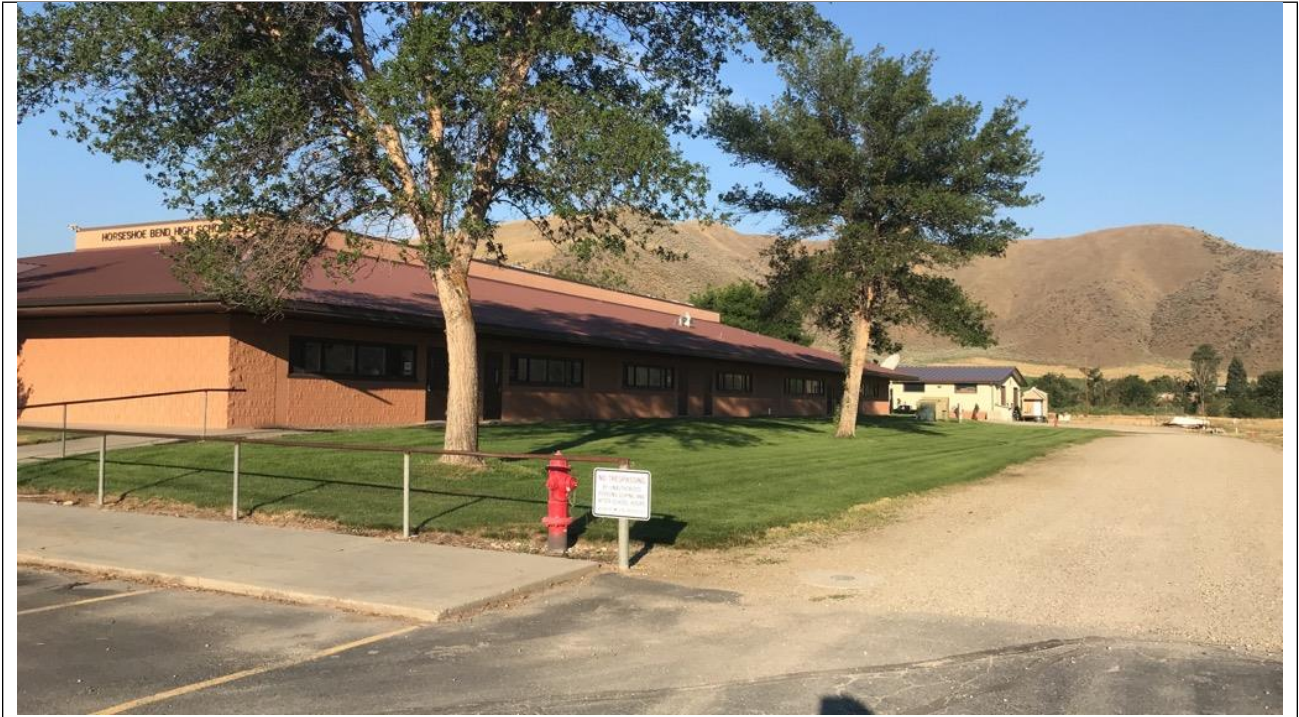
GRAVEL ACCESS DRIVE / HYDRANT AT THE NORTH OF HIGH SCHOOL

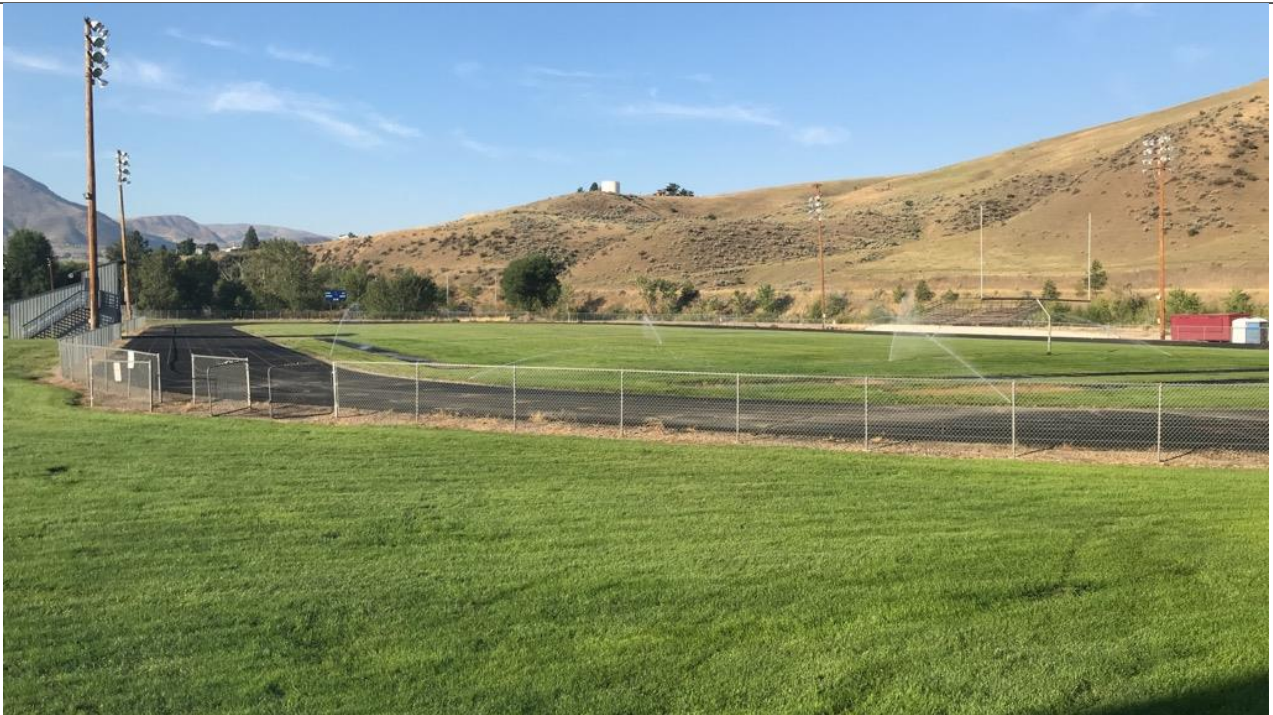
FOOTBALL FIELD AND TRACK. RUNNING TRACK IS IN POOR CONDITION

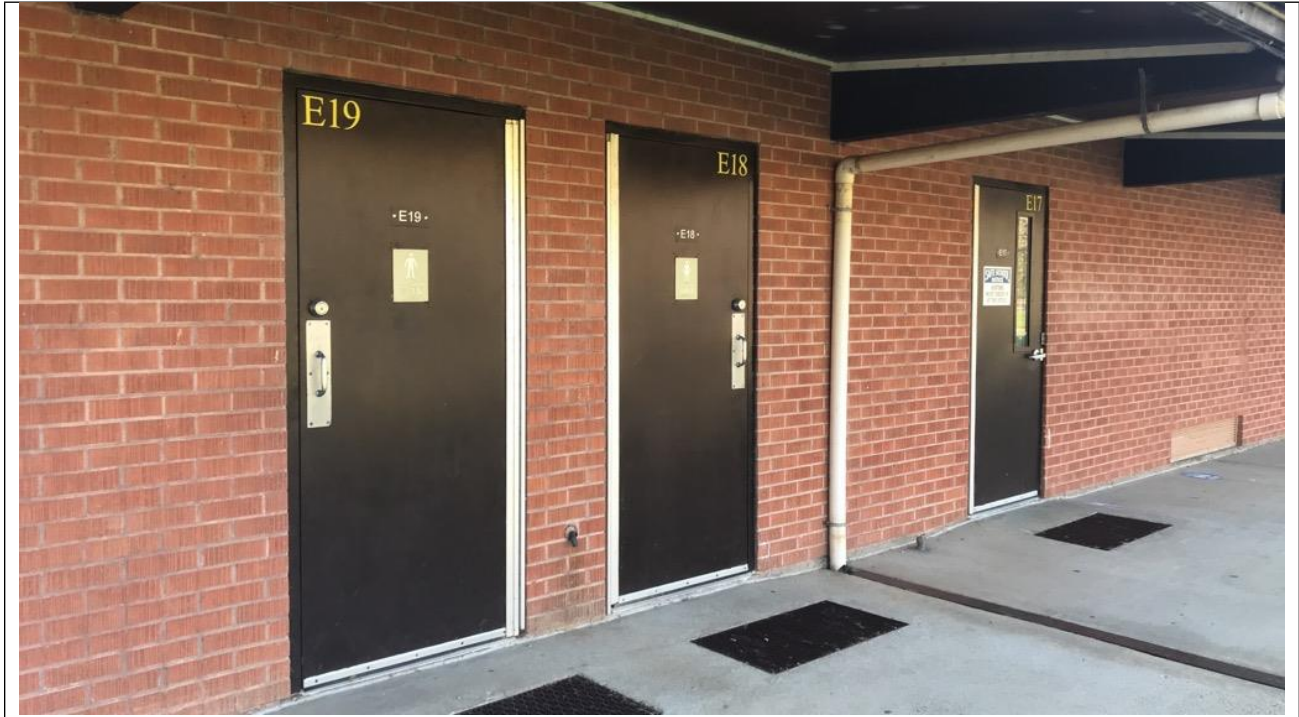
The high school and middle school low slope roof drains are being piped to subsurface drainage beds. The condition of the subsurface beds is undetermined.	3
------------------------------------------------------------------------------------------------------------------------------------------------------------	---

EXTERIOR DOWNSPOUTS TO SOLID FLOOR DRAIN CAUSING DRAINAGE ISSUES

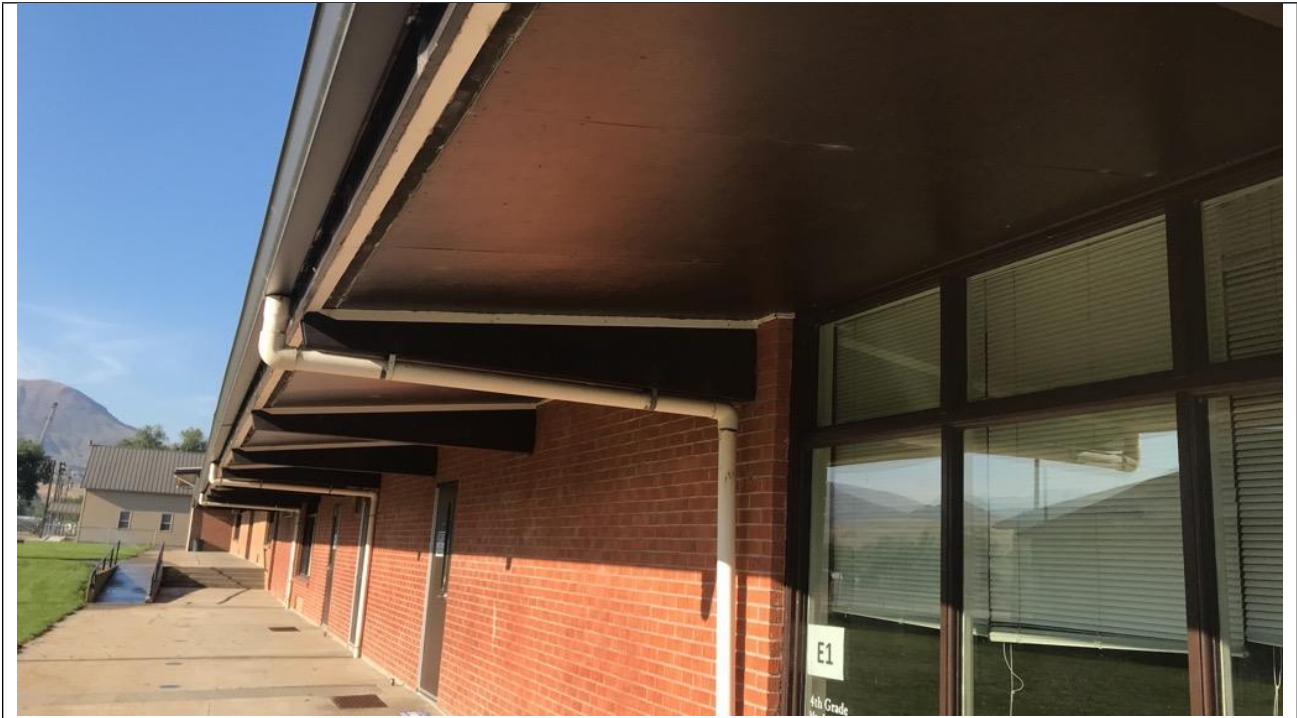
OVERHANG WITH DOWNSPOUTS. WATER DAMAGE AT SOFFIT FROM DRAINAGE

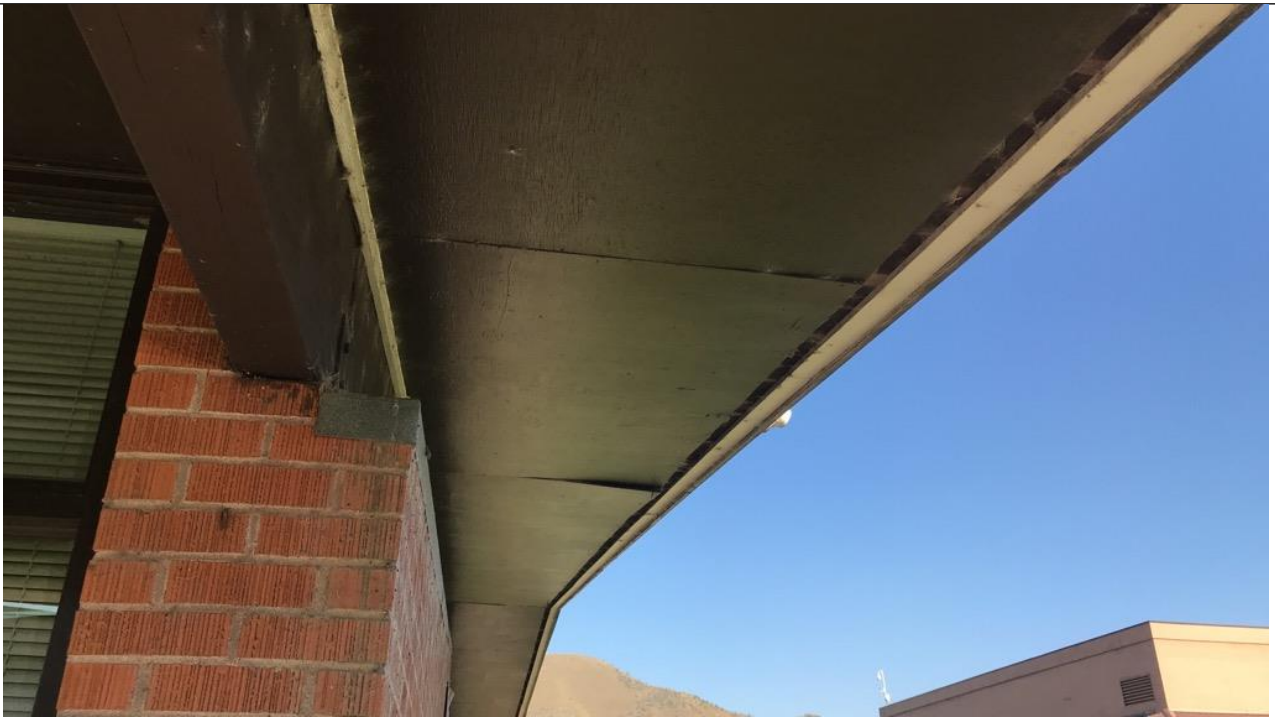
WOOD SOFFIT MATERIAL DAMAGED AND SHOWING AGE FROM WATER DAMAGE

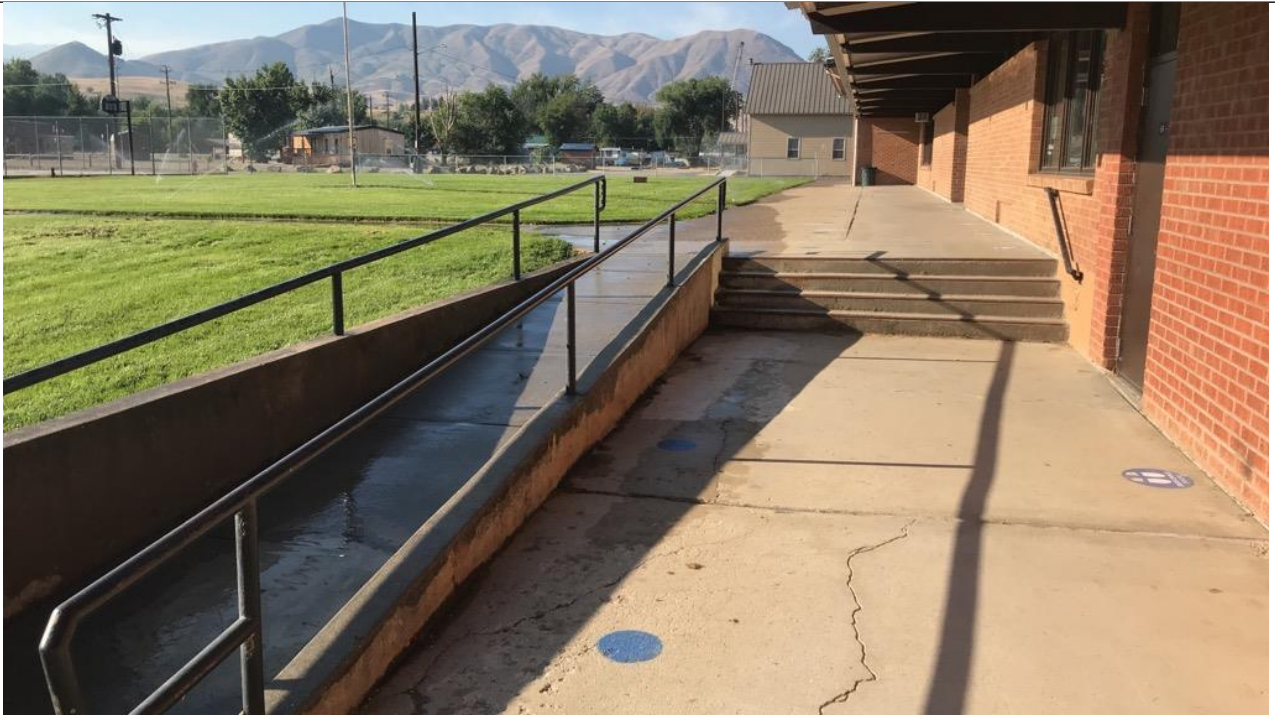
Exterior ramp does not meet ADA requirements. The sidewalk outside of the covered walkway system is showing spalling and cracking due to weather conditions and salt being applied to the surface during winter conditions.	1
-----------------------------------------------------------------------------------------------------------------------------------------------------------------------------------------------------------------------------	---

RAMP AND HANDRAILS DO NOT MEET ADA. CONCRETE IS SPALLING / CRACKING

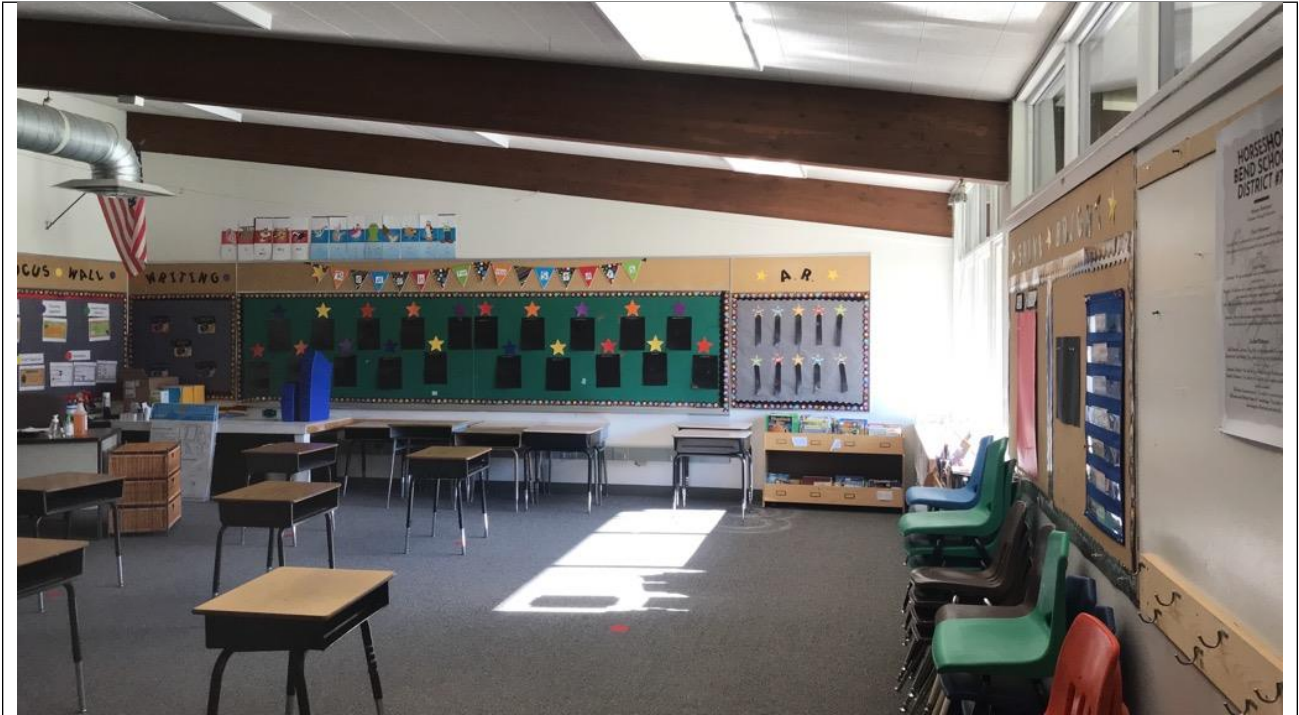
TYPICAL CLASSROOM – NO FIRE SPRINKLER SYSTEM

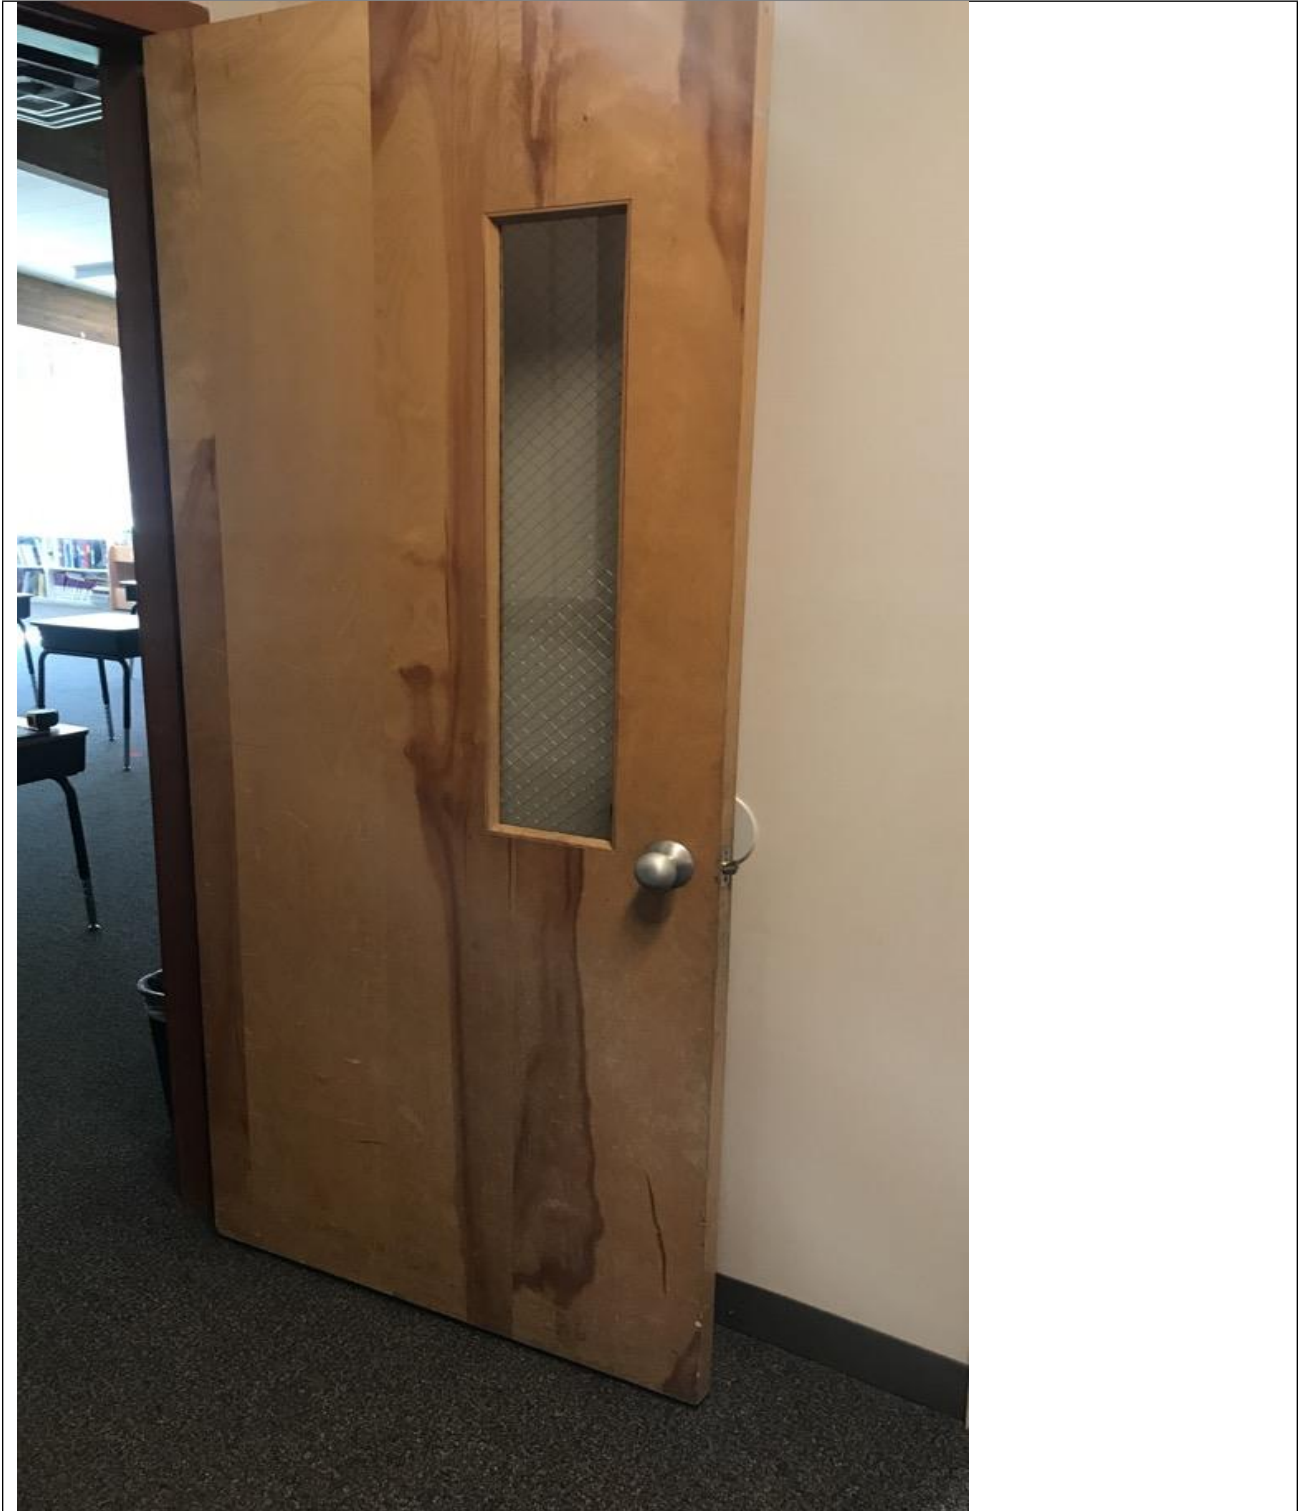
Majority of the door hardware throughout the facility does not meet ADA requirements and should be replaced with new doors and hardware.	1
------------------------------------------------------------------------------------------------------------------------------------------	---

INTERIOR DOORS TO CLASSROOMS / HARDWARE DOES NOT MEET ADA

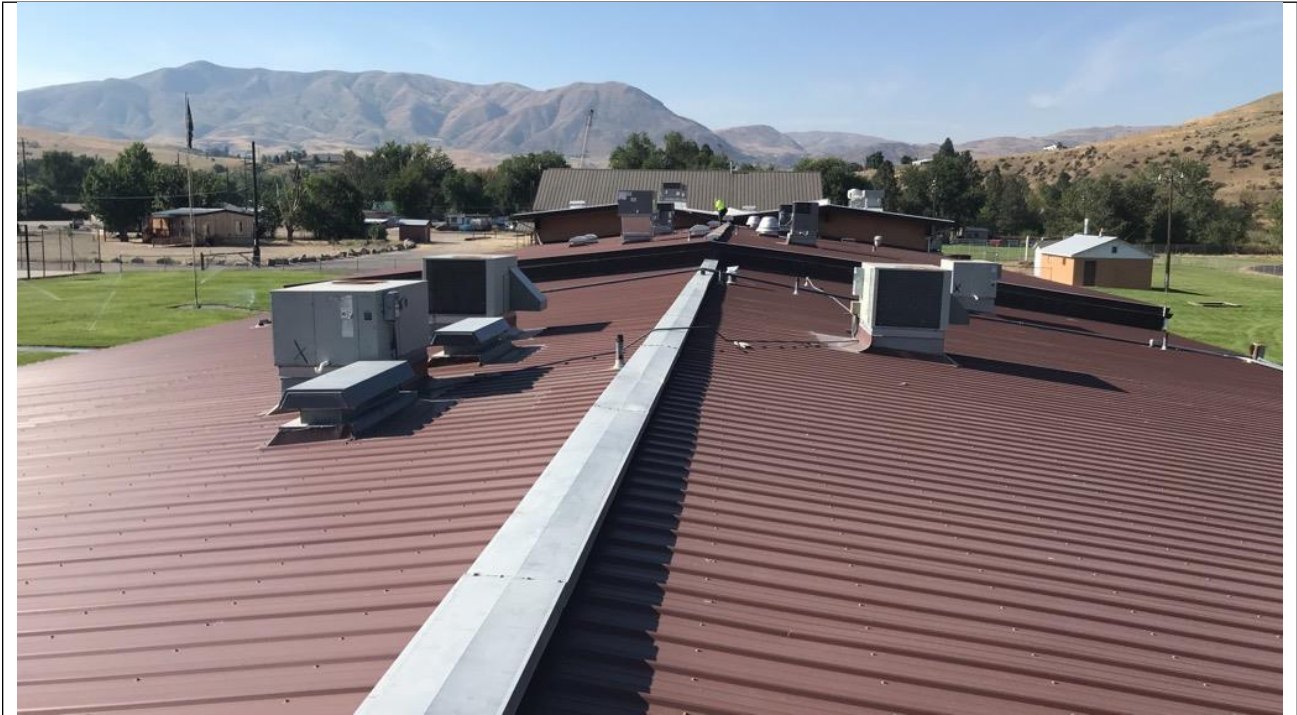
METAL ROOF / FAIR CONDITION

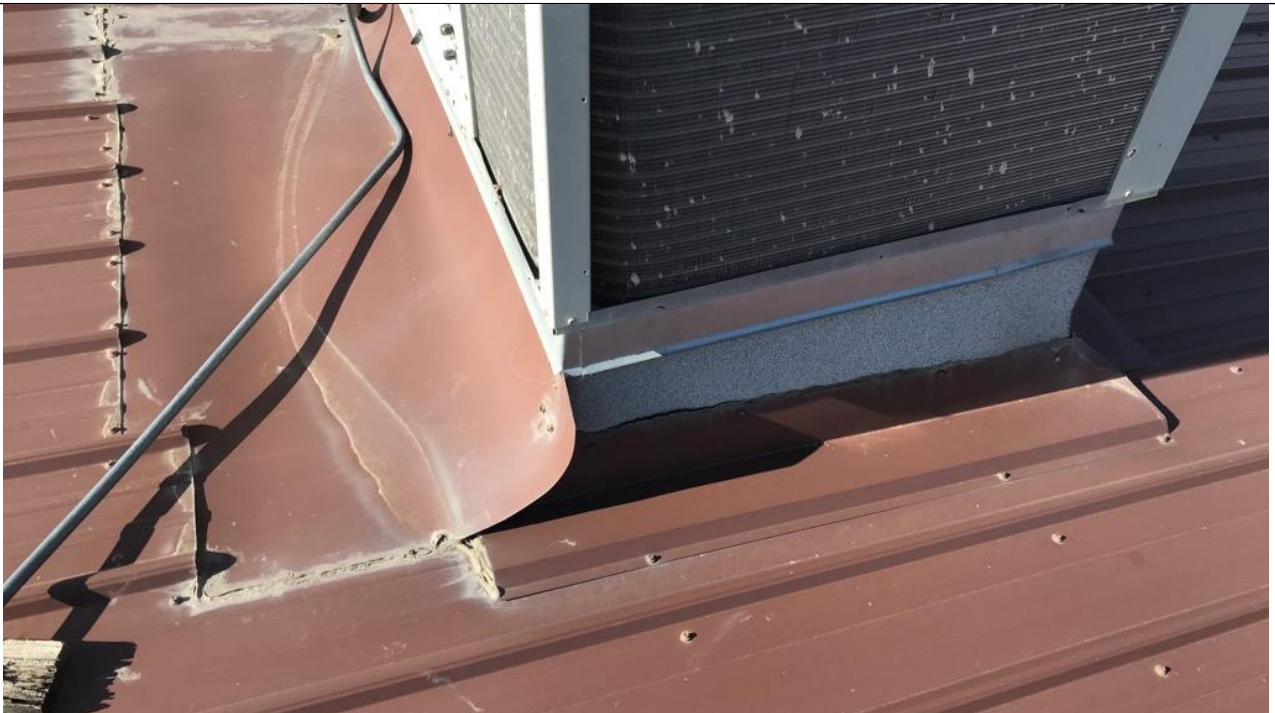
Roof top mounted equipment on curbs at the sloped metal roof areas. Are in fair condition. New flashing and roofing crickets should be installed to achieve better positive drainage to the existing roof drains and overflows.	1
---------------------------------------------------------------------------------------------------------------------------------------------------------------------------------------------------------------------------------	---

PENETRATIONS AT HVAC UNITS ARE IN POOR CONDITION

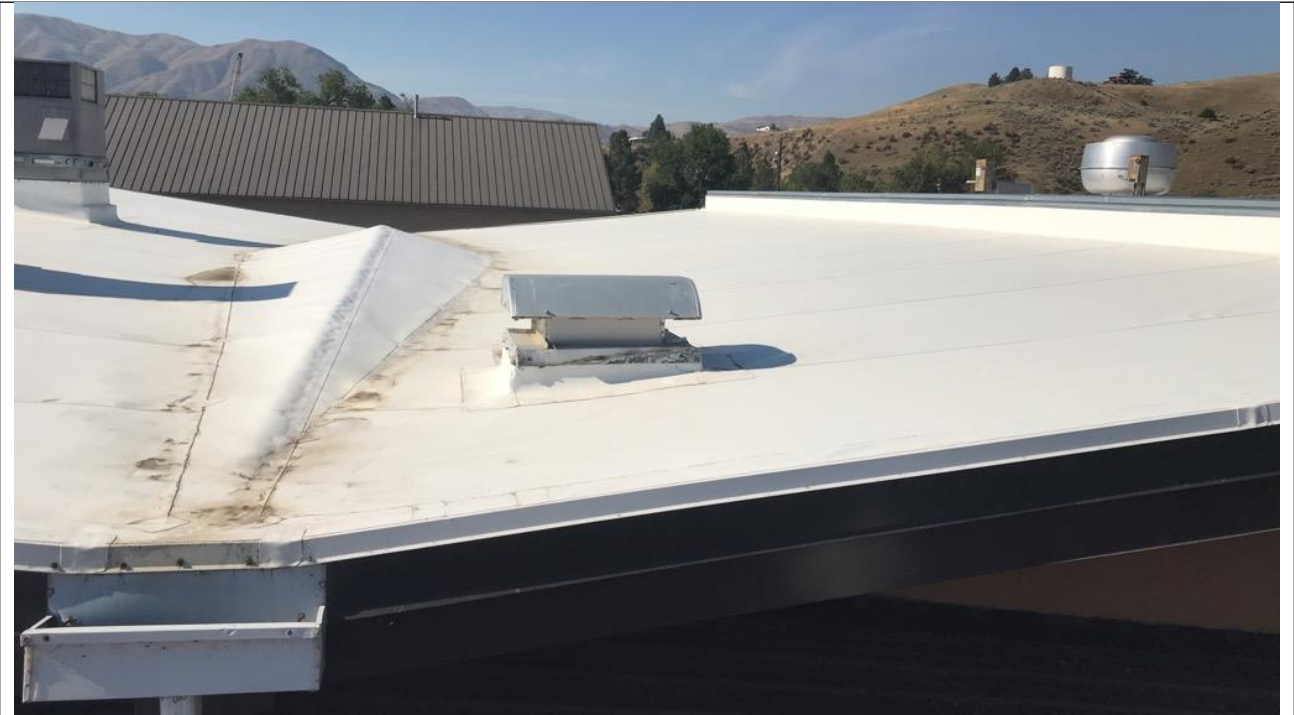
SINGLE PLY MEMBRANE ROOF AT CAFETERIA IS IN GOOD CONDITION. DRAIN TO LOWER ROOF NEED REPAIR TO PREVENT LEAKING

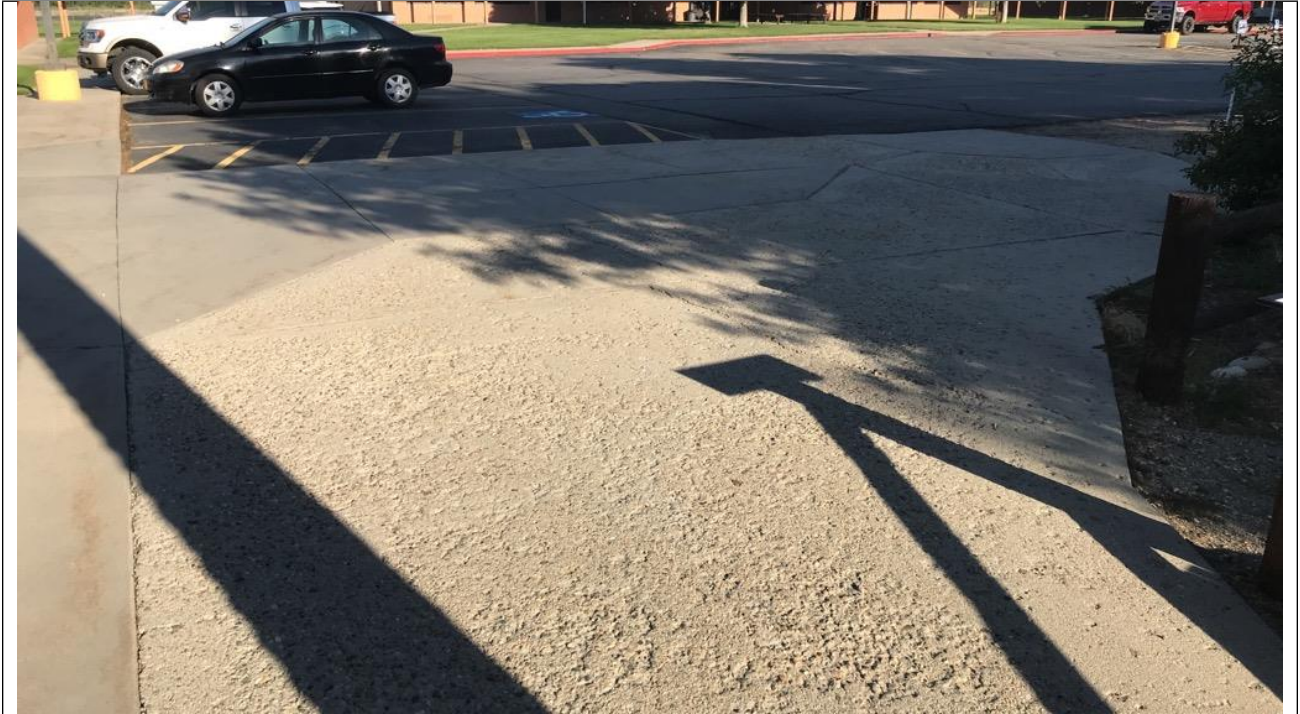
Main entry is accessible at concrete sidewalk. The sidewalk is showing spalling and cracking due to weather conditions and salt being applied to the surface during winter conditions.	4
----------------------------------------------------------------------------------------------------------------------------------------------------------------------------------------	---

SIDEWALK LEADING TO MAIN ENTRY / CONCRETE IS SPALLING

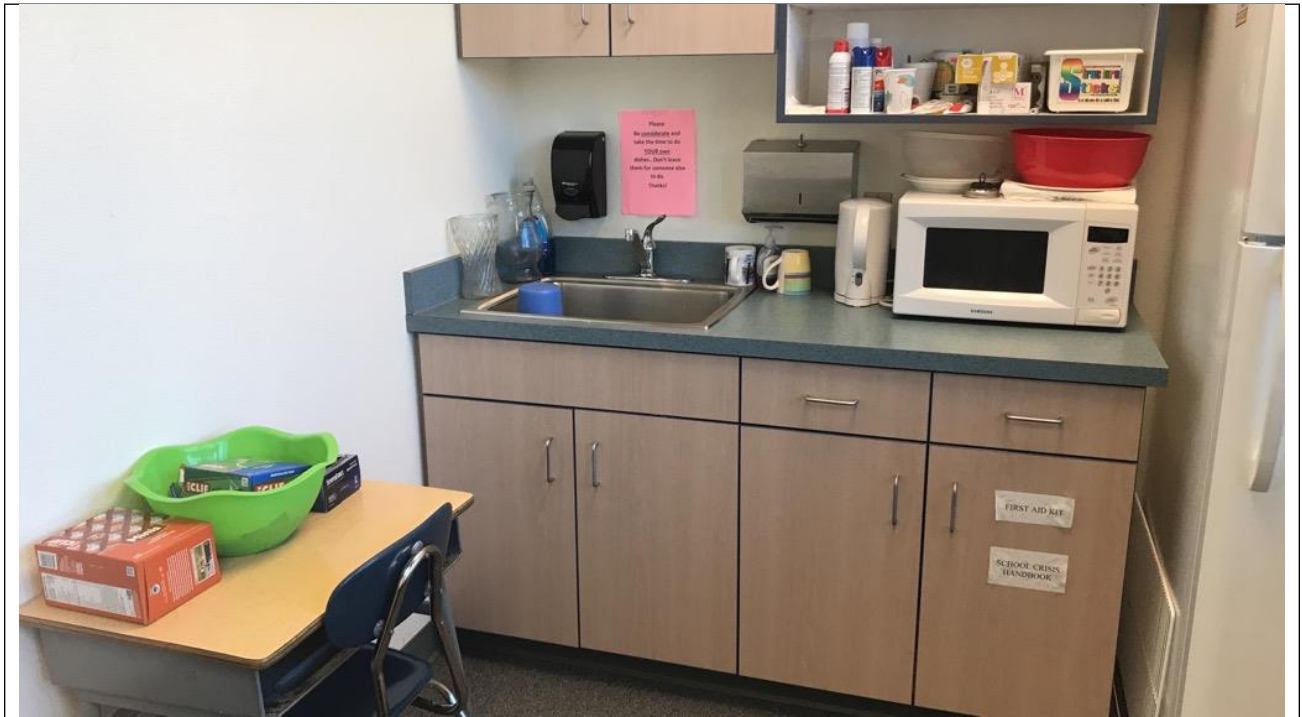
Plastic laminate cabinets and counter tops. Good condition. All cabinets meet ADA requirements except for the sink cabinet in the Faculty office area. It is 36" in height should be 34".	4
-------------------------------------------------------------------------------------------------------------------------------------------------------------------------------------------	---

FACULTY BREAK AREA – COUNTER DOES NOT MEET ADA REQUIREMENTS

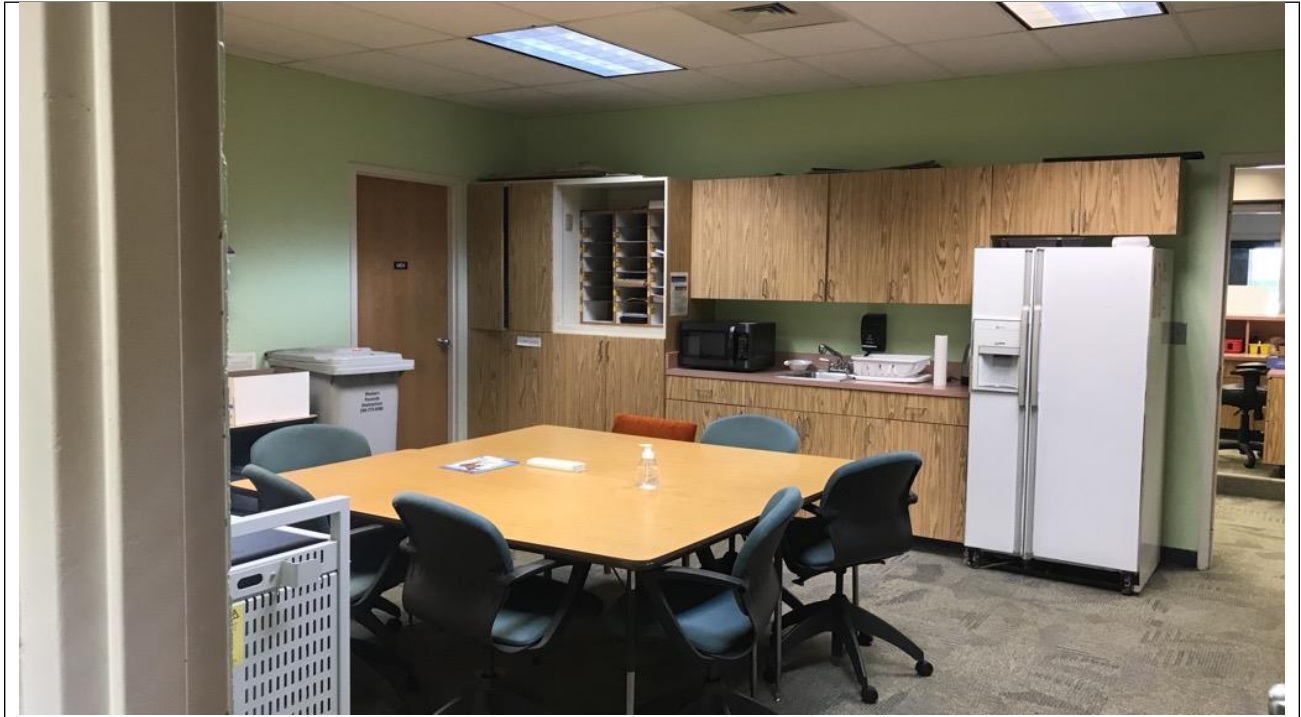
FACULTY ROOM / COUNTER HEIGHT DOES NOT MEET ADA REQUIREMENTS

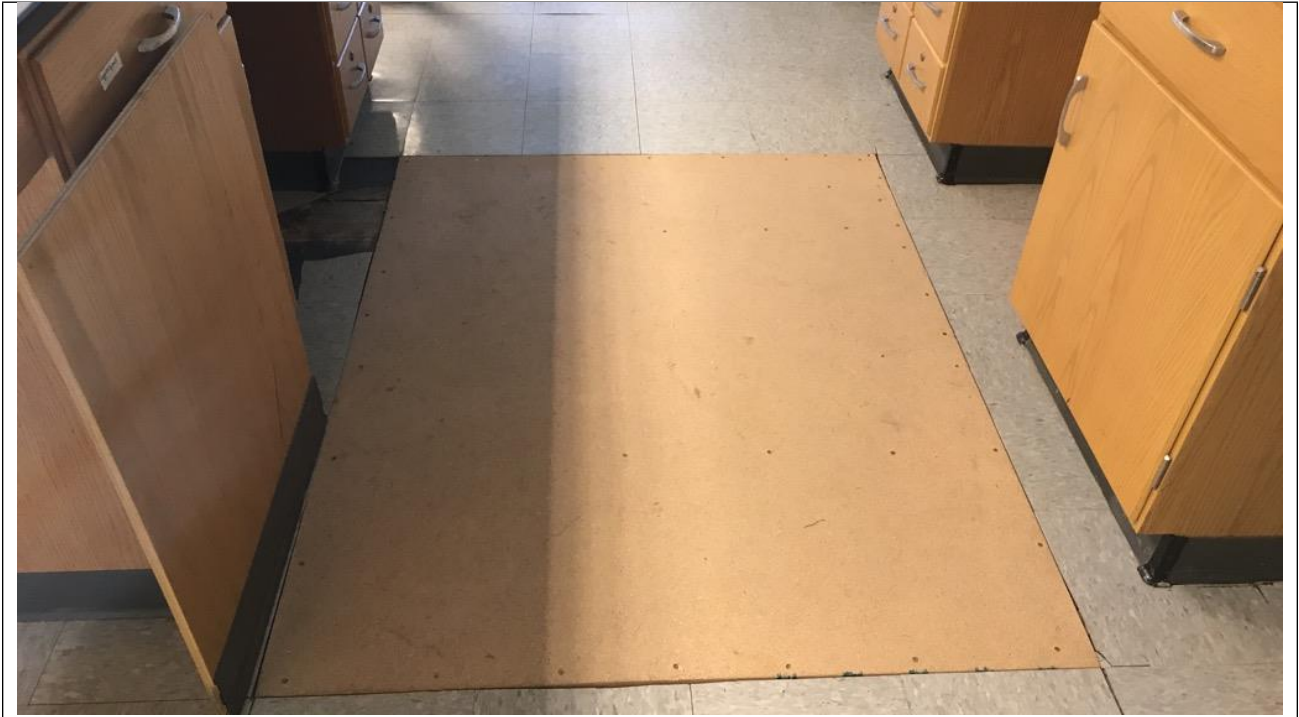
4" concrete slab on grade at most locations.	5
The science labs have a crawl space / framed floor system. There has been a water leak at the Chemistry classroom that has caused damage.	3

WATER DAMAGE FROM WATER LEAK / CHEMISTRY CLASSROOM

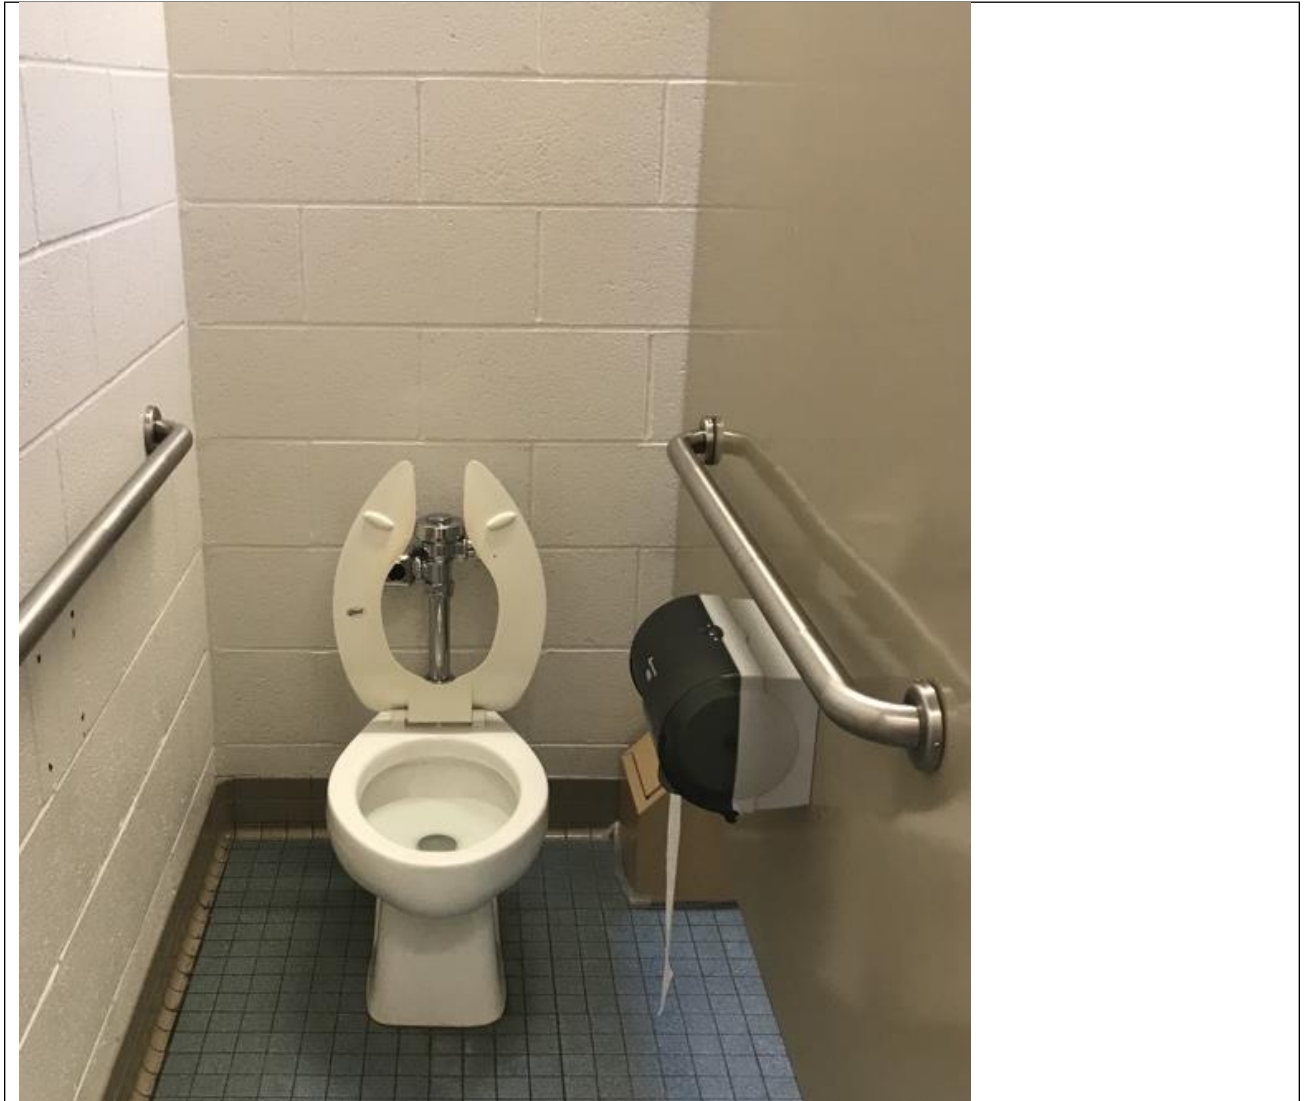
RESTROOMS / NO ADA COMPLIANT STALL

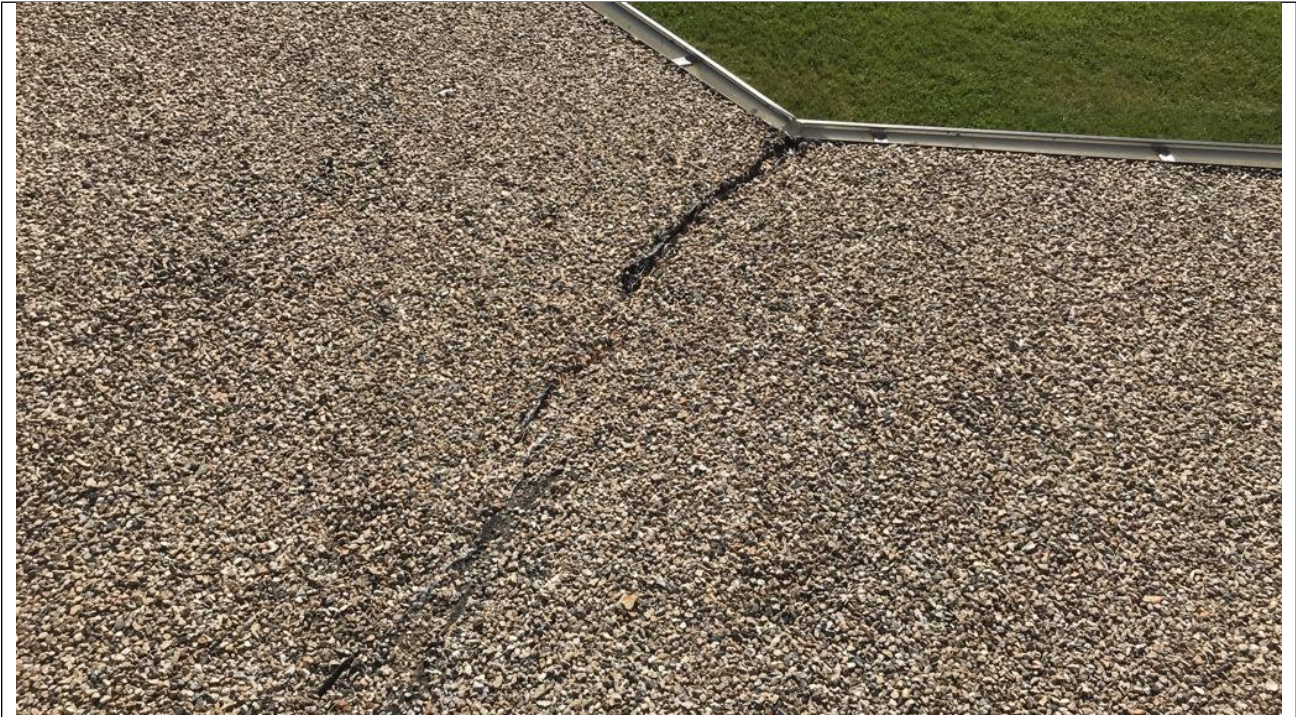
GRAVEL COVERED BUILT UP ROOFING – FLAT / SHOWING WEAR IN MANY LOCATIONS

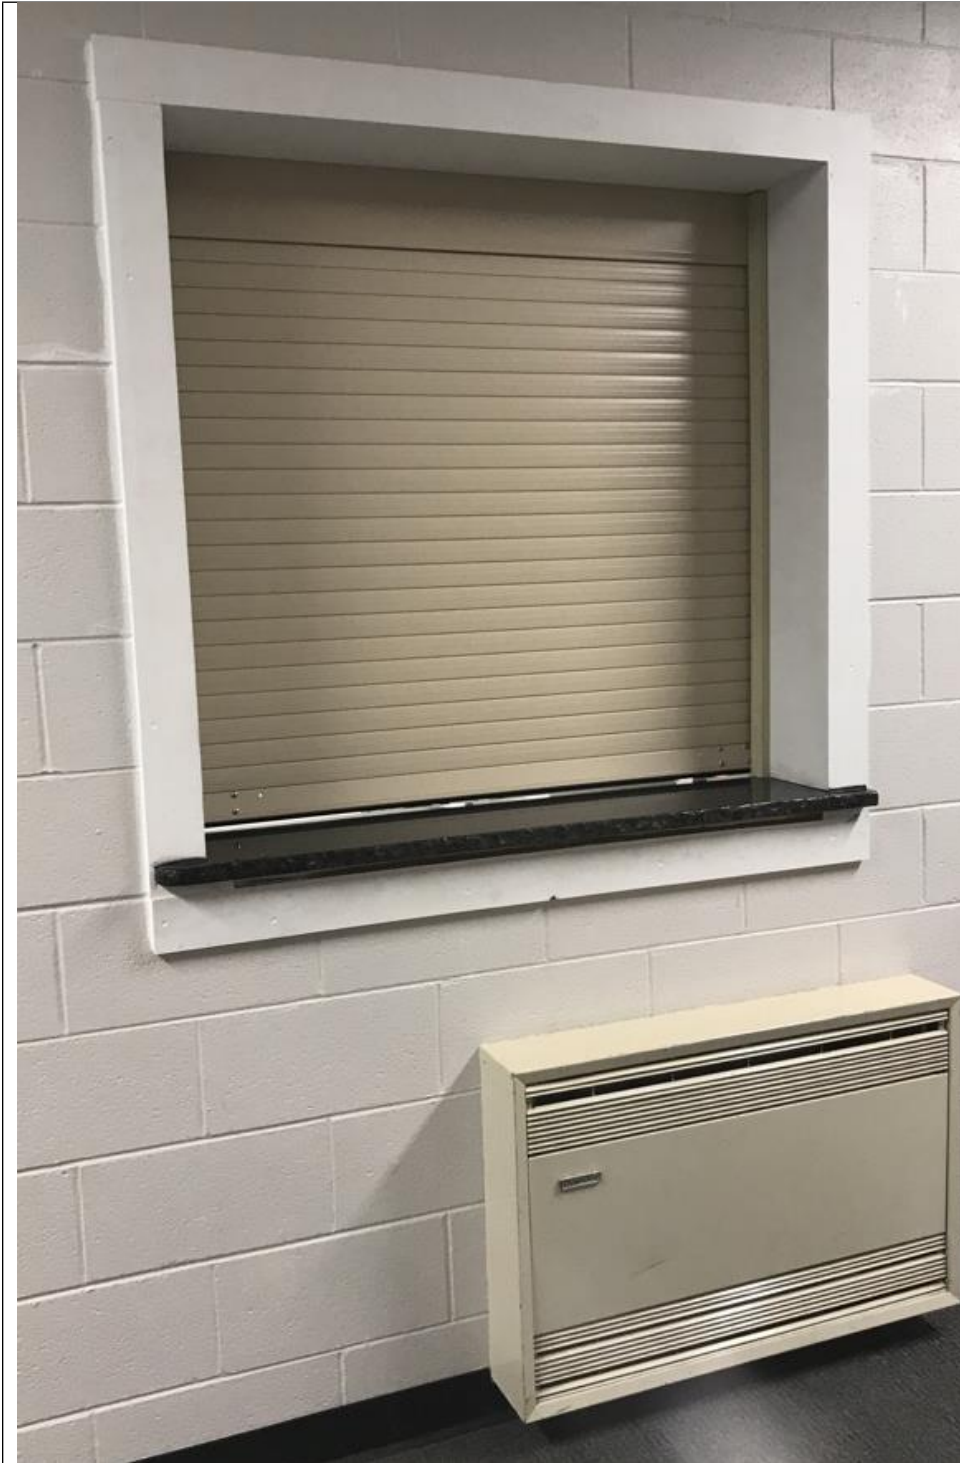
CONCESSIONS WINDOW IS NOT ACCESSIBLE – SILL IS AT 42”

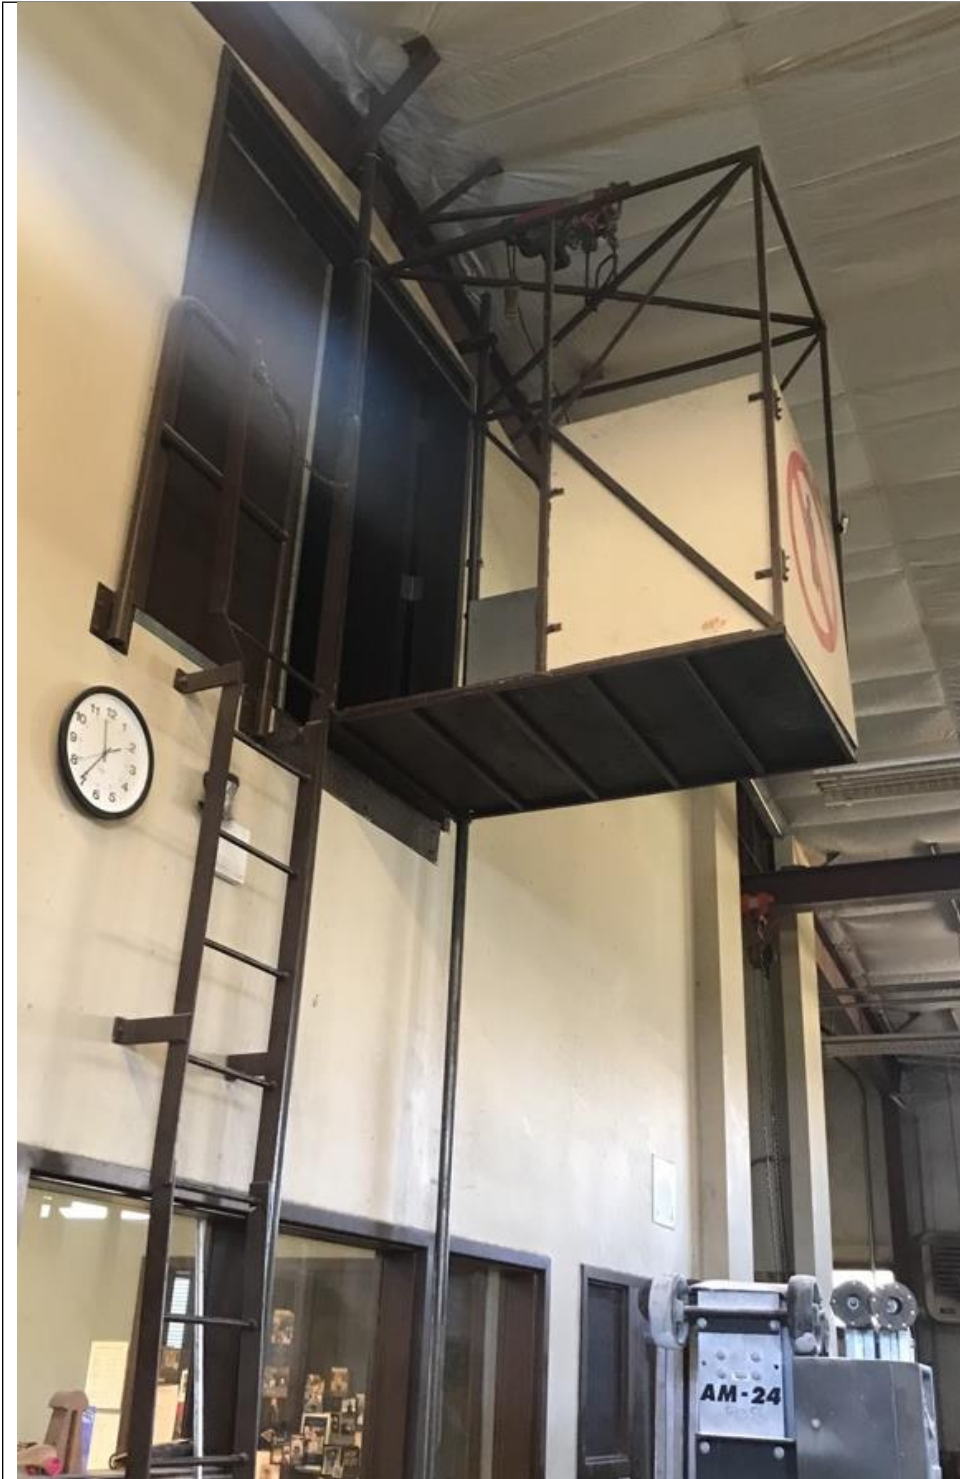
DUMBWAITER / LIFT IS NOT OPERATIONAL
LADDER ACCESS TO MECHANICAL PLATFORM
