FACILITIES ASSESSMENT AND GROWTH PROJECTION REPORT

Horseshoe Bend

School District No. 73

Horseshoe Bend, Idaho
September 21, 2021

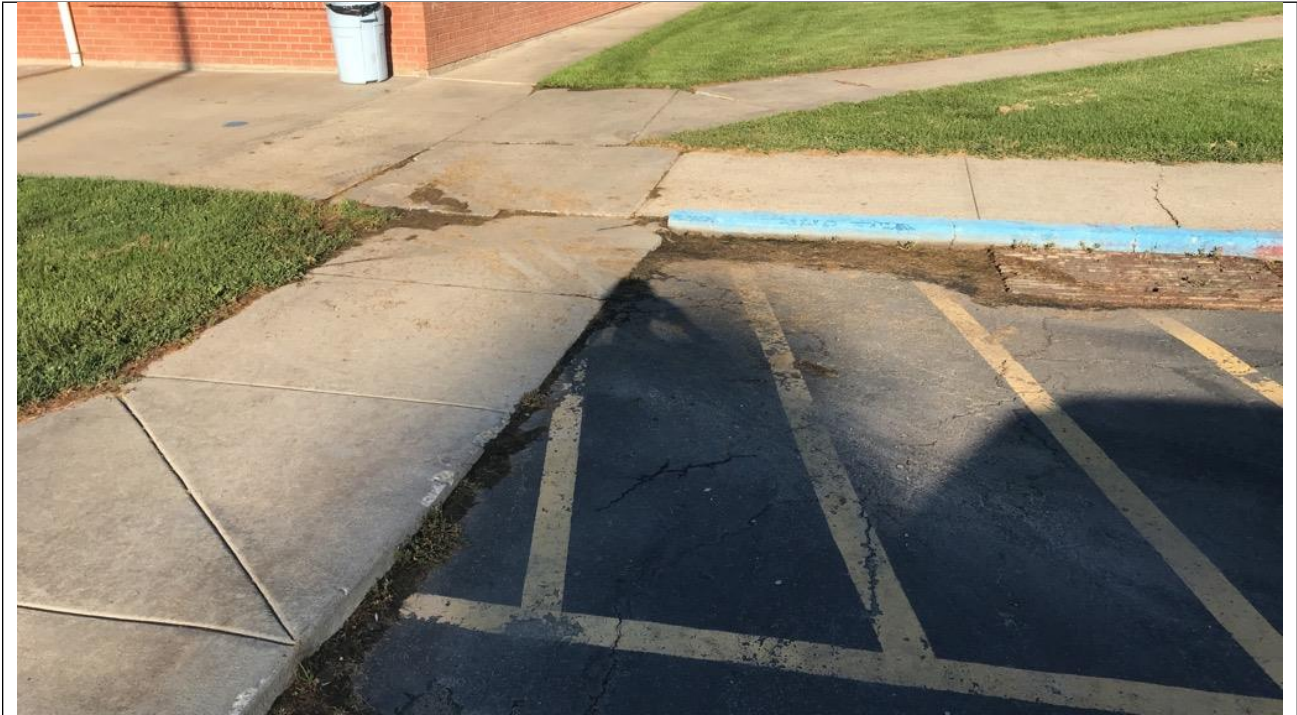
ADA SIDEWALK ACCESS ISSUES AT MAIN PARKING LOT BY ELEMENTARY

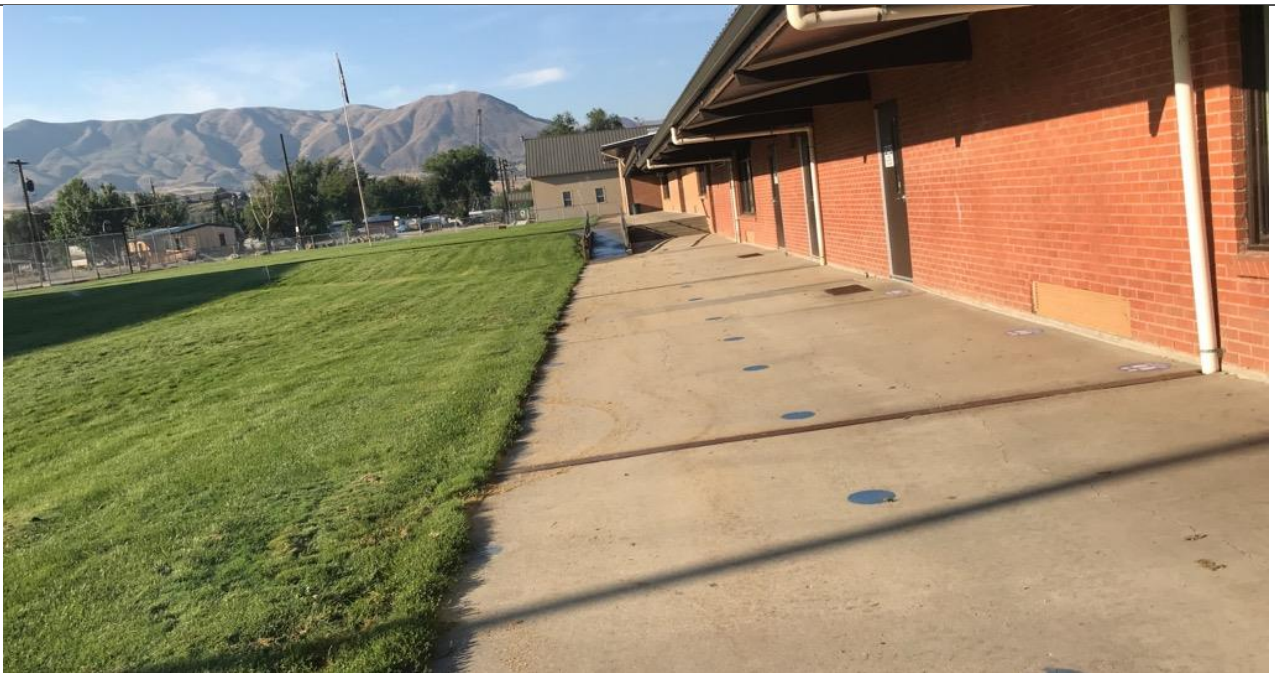
WALKWAY AT EAST SIDE OF ELEMENTARY / DOWNSPOUT DRAINAGE ISSUES UNDER CONCRETE SLAB AND CONNECTION POINT TO DOWNSPOUT

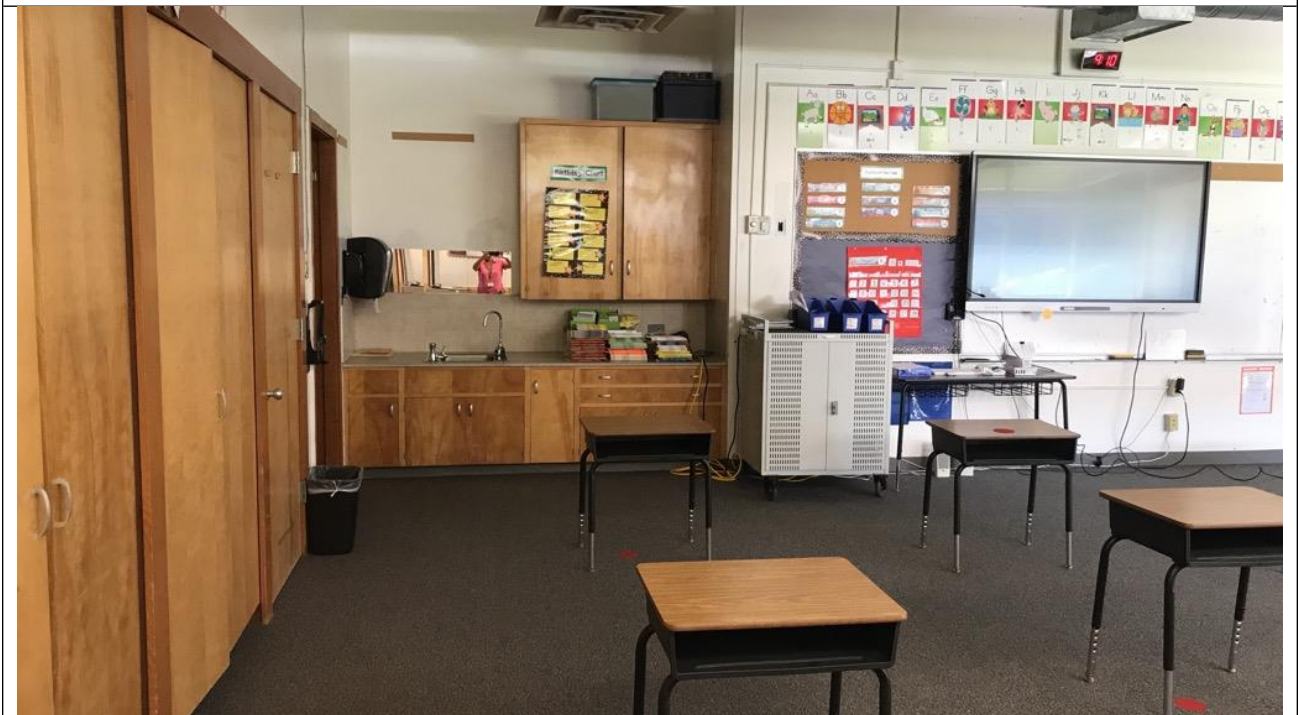
CABINETS ARE DATED. CLASSROOM TECHNOLOGY IS ALL SURFACED MOUNTED ELECTRICAL RACEWAYS

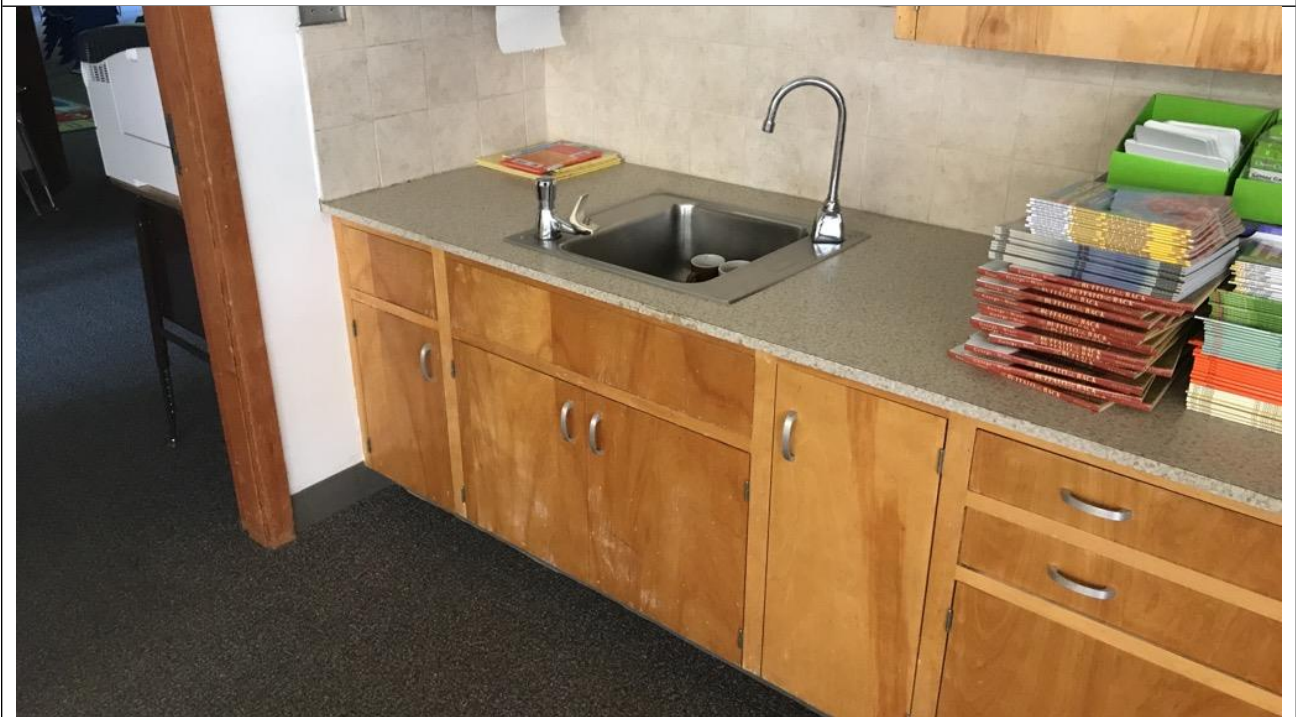
SINK CABINETS DO NOT MEET ADA REQUIREMENTS

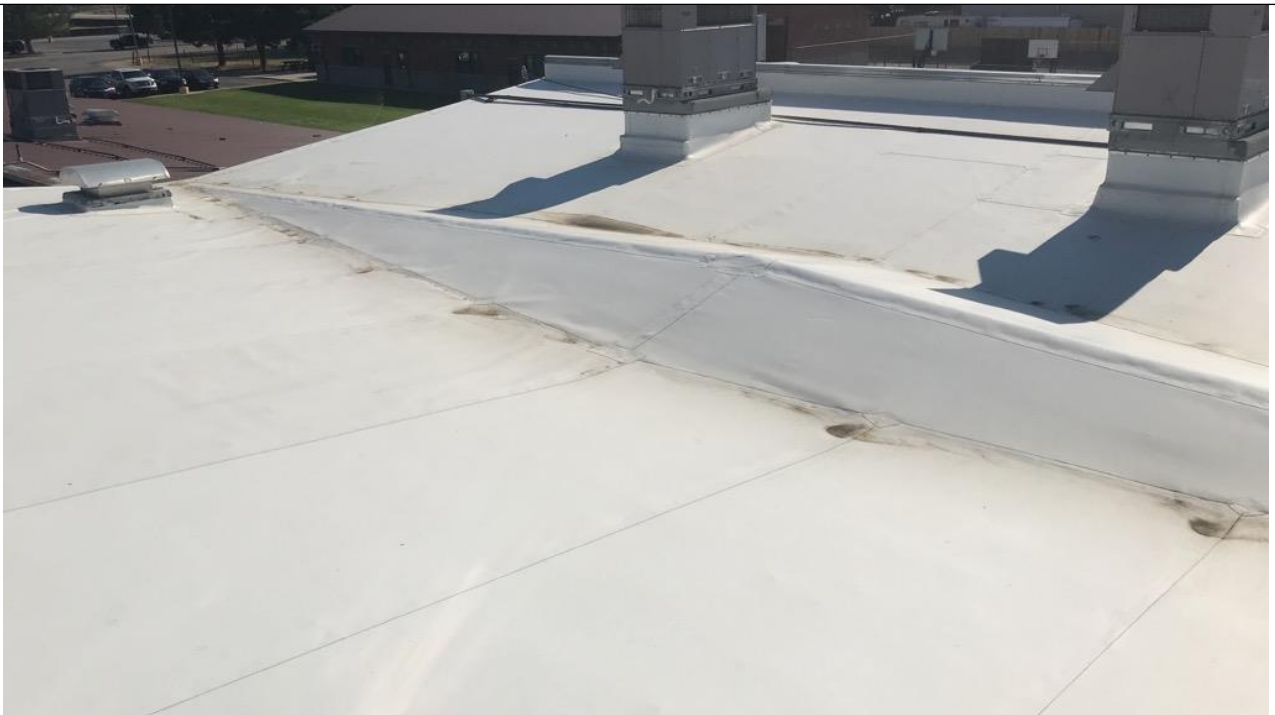
CRICKET AT LOW SLOPE ROOF TOWARD DRAIN TO LOWER METAL ROOF

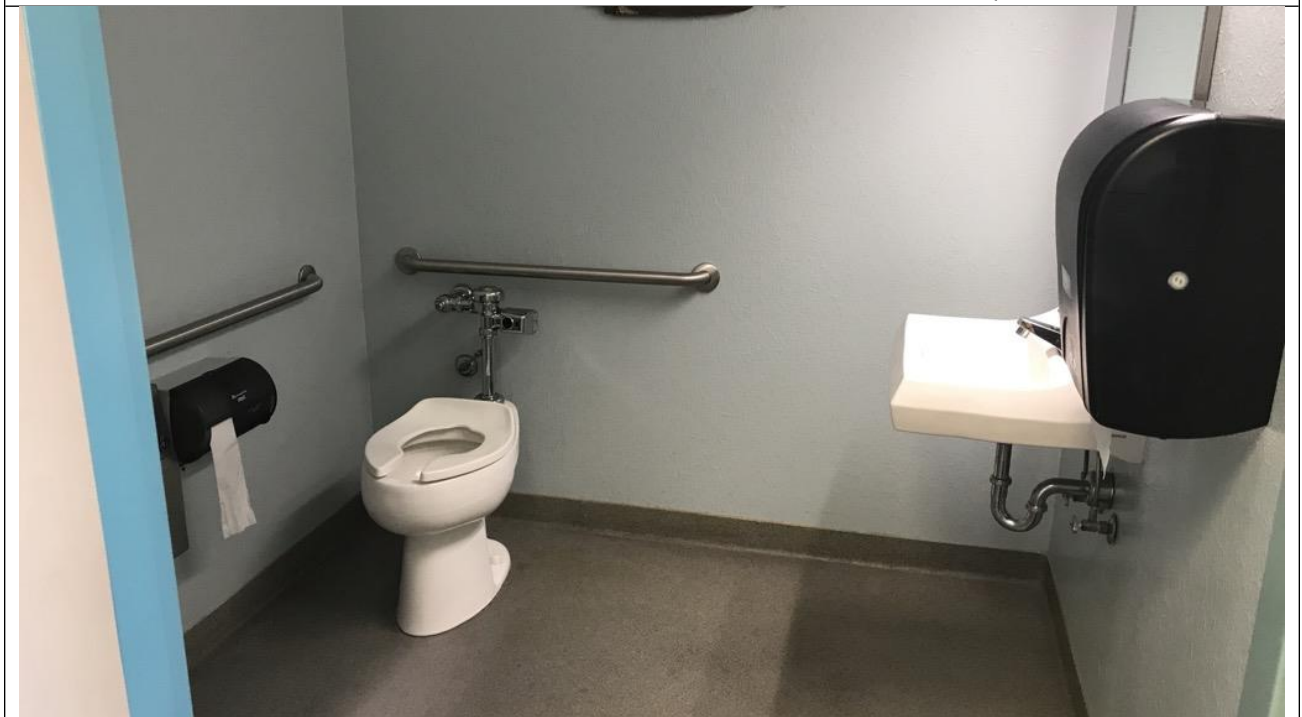
FACULTY RESTROOM / ADA COMPLIANT

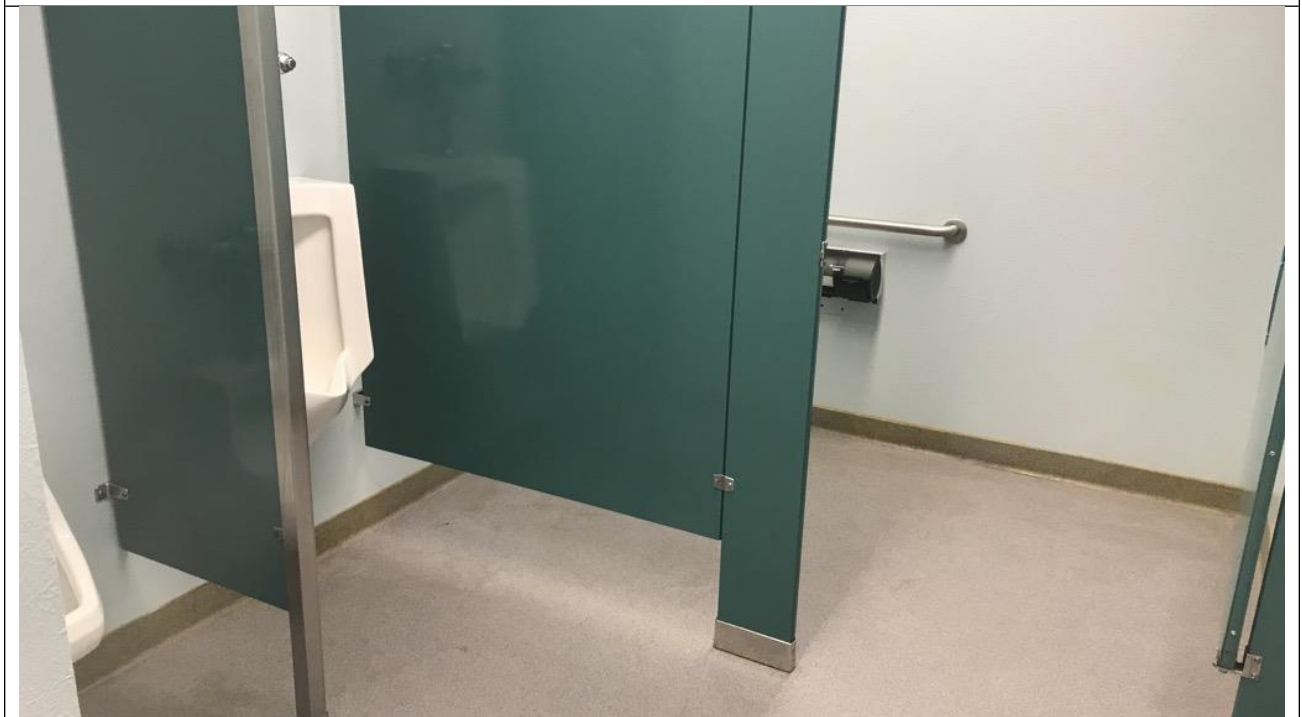
RESTROOMS / ADA COMPLIANT

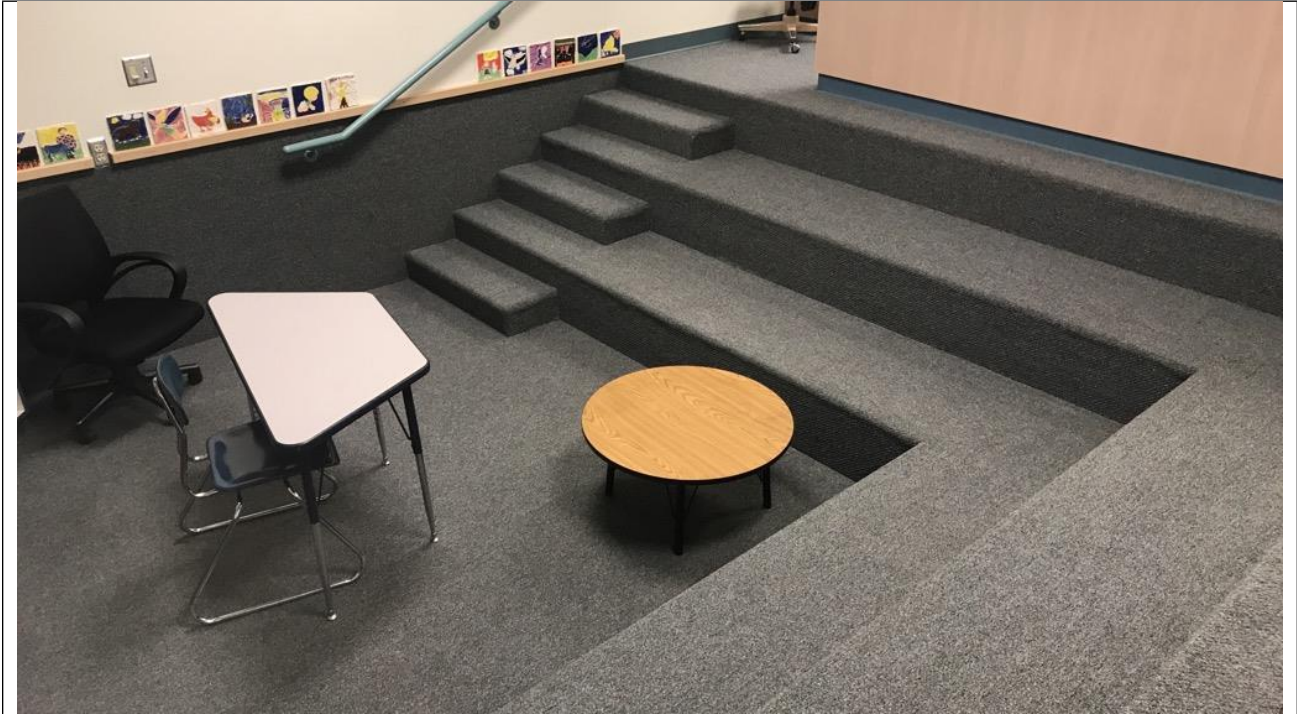
RECESSED READING AREA DOES NOT MEET ADA REQUIREMENTS

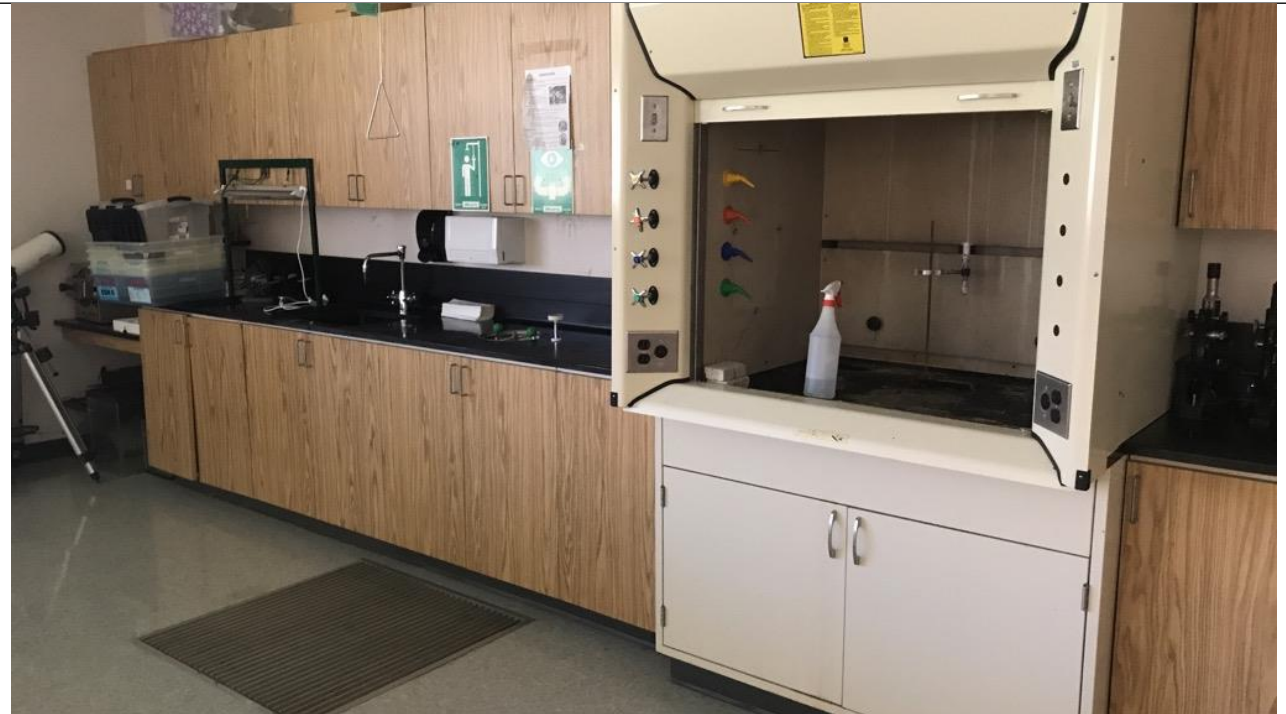
FUME HOOD AND EYE WASH STATION

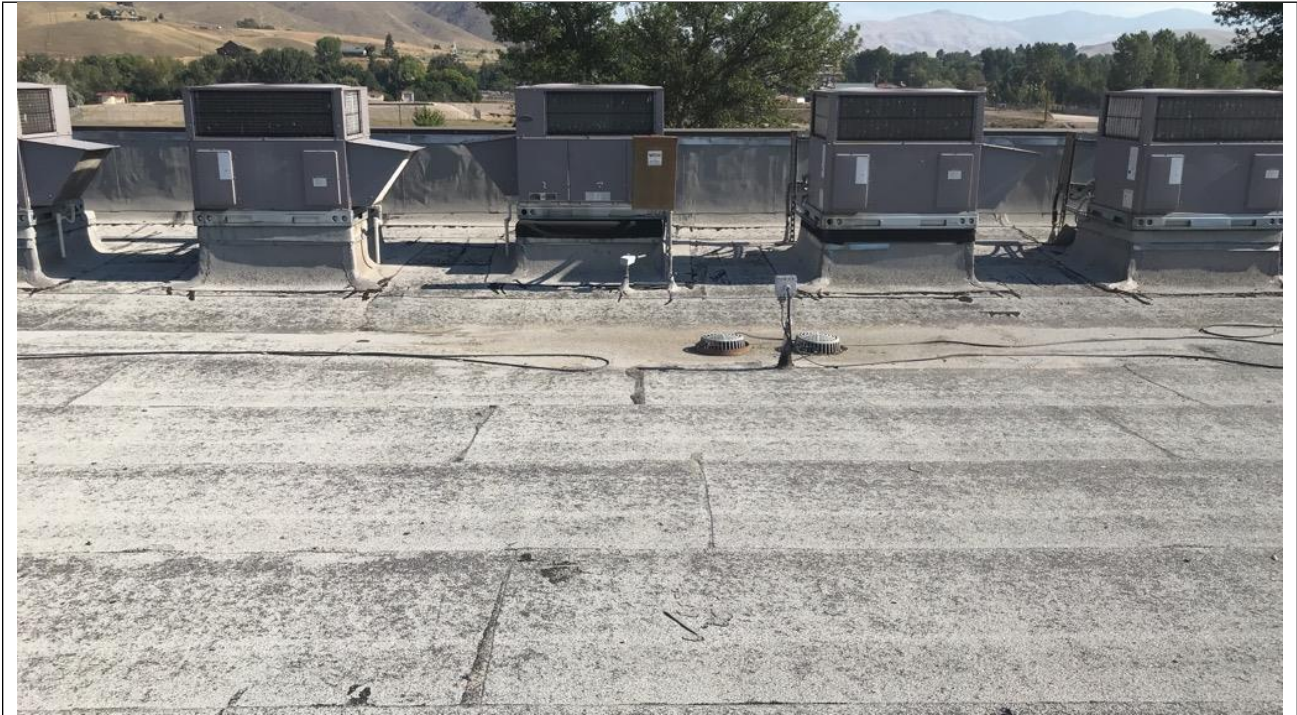
ROOF DRAIN AND OVERFLOW / SURROUNDED BY HEAT TAPE

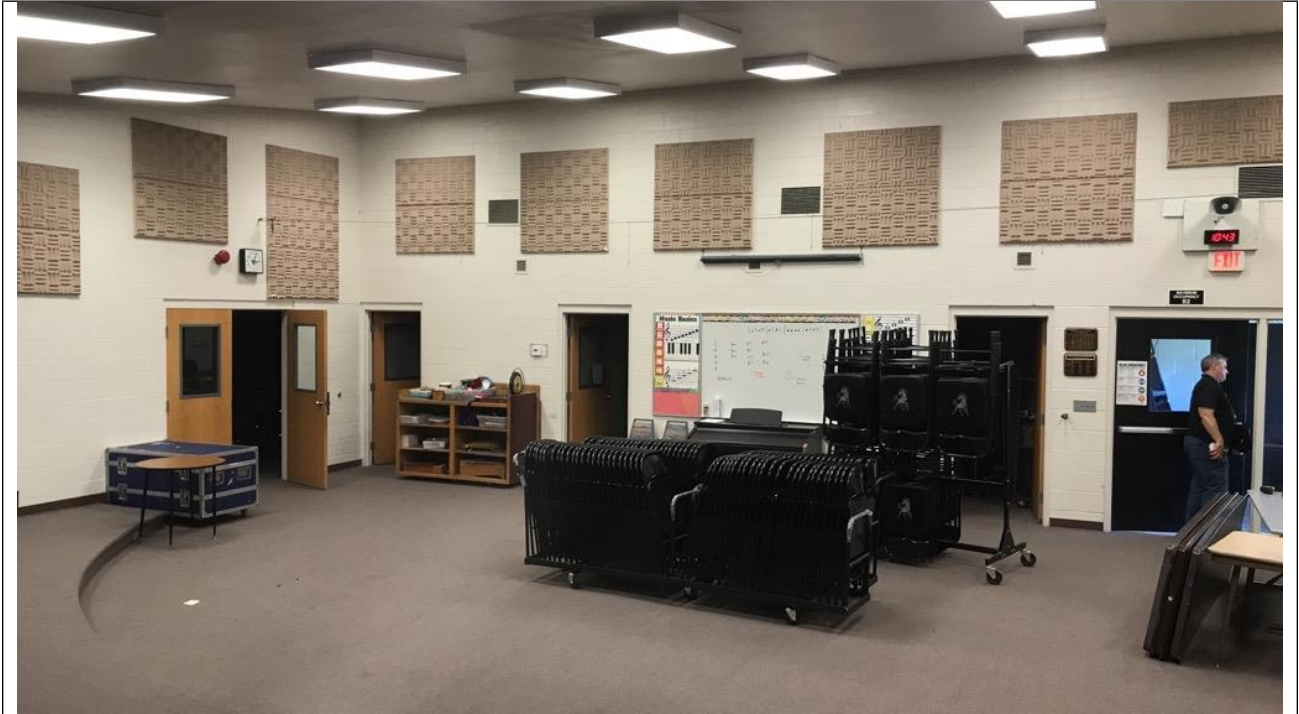
OFFICE / PRACTICE ROOMS / STORAGE BACK WALL

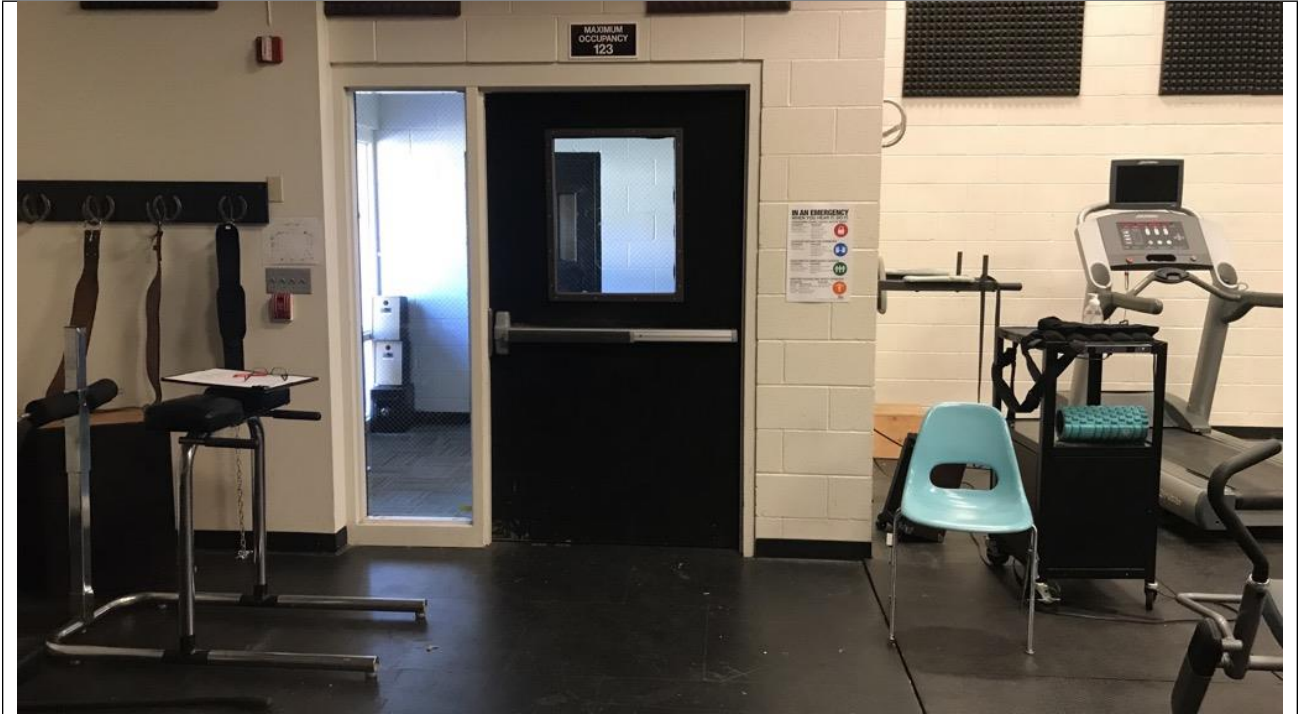
ACCESS CONTROL AT WEIGHT ROOM DOOR

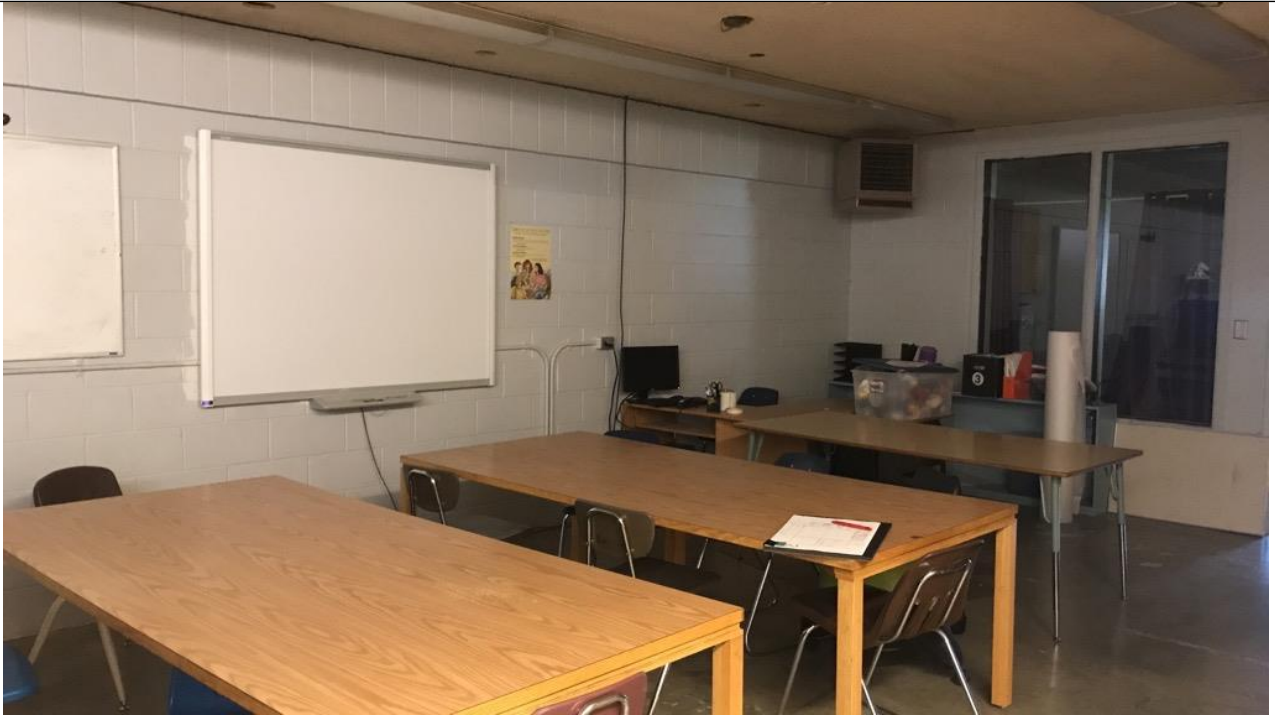
RESOURCE ROOM AT NORTH END OF GYMNASIUM

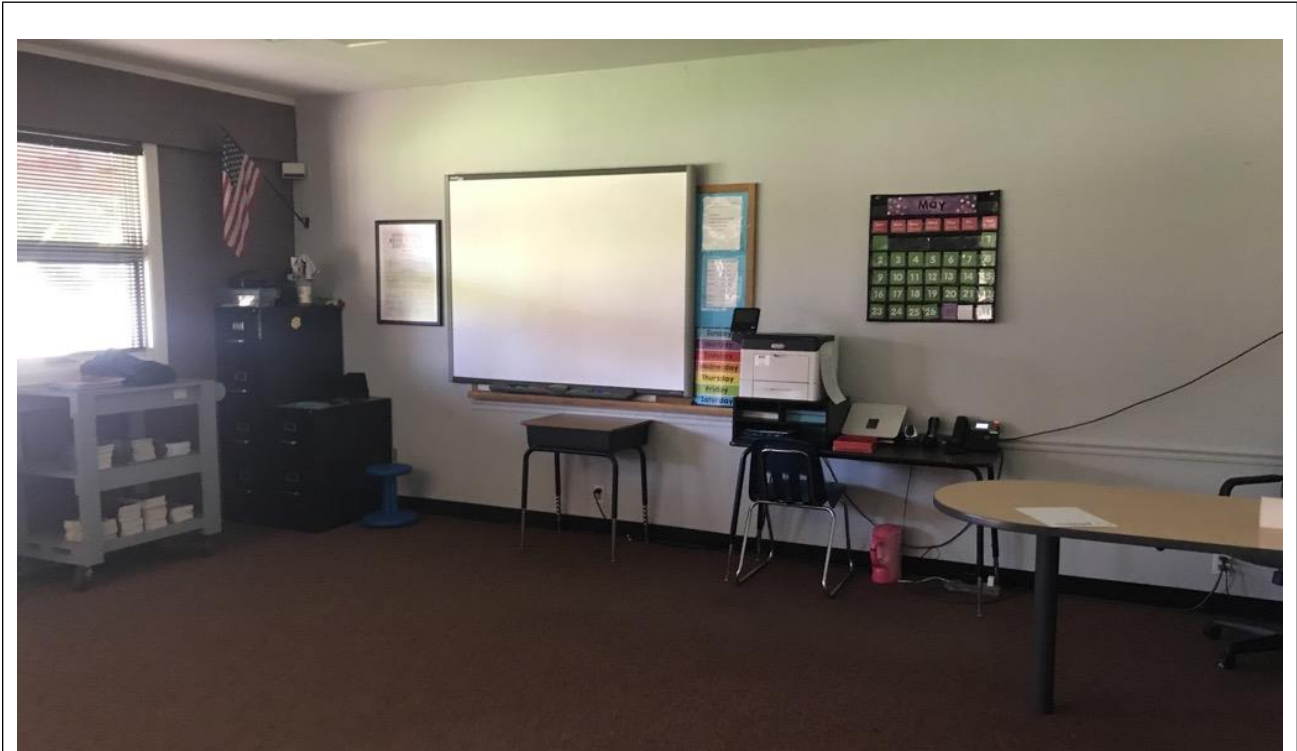
RESOURCE ROOM AT NORTH EAST CLASSROOM

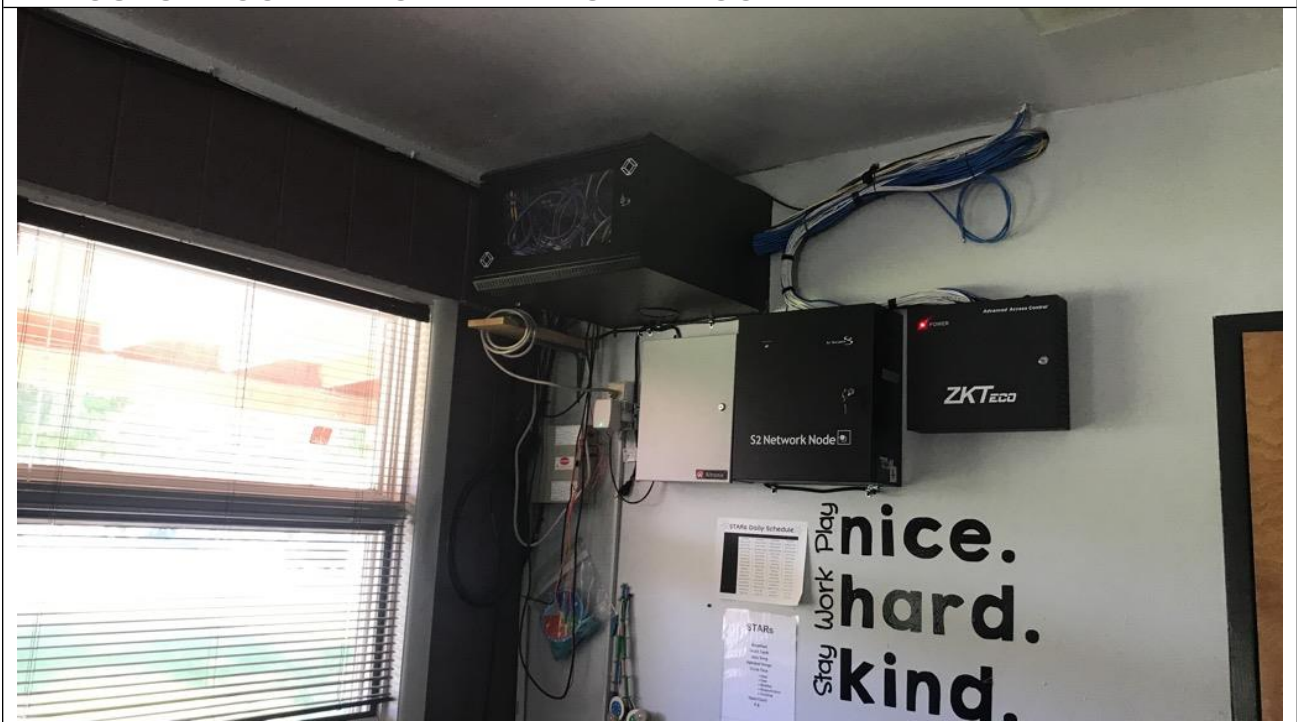
IT RACKS AT RESOURCE CLASSROOM

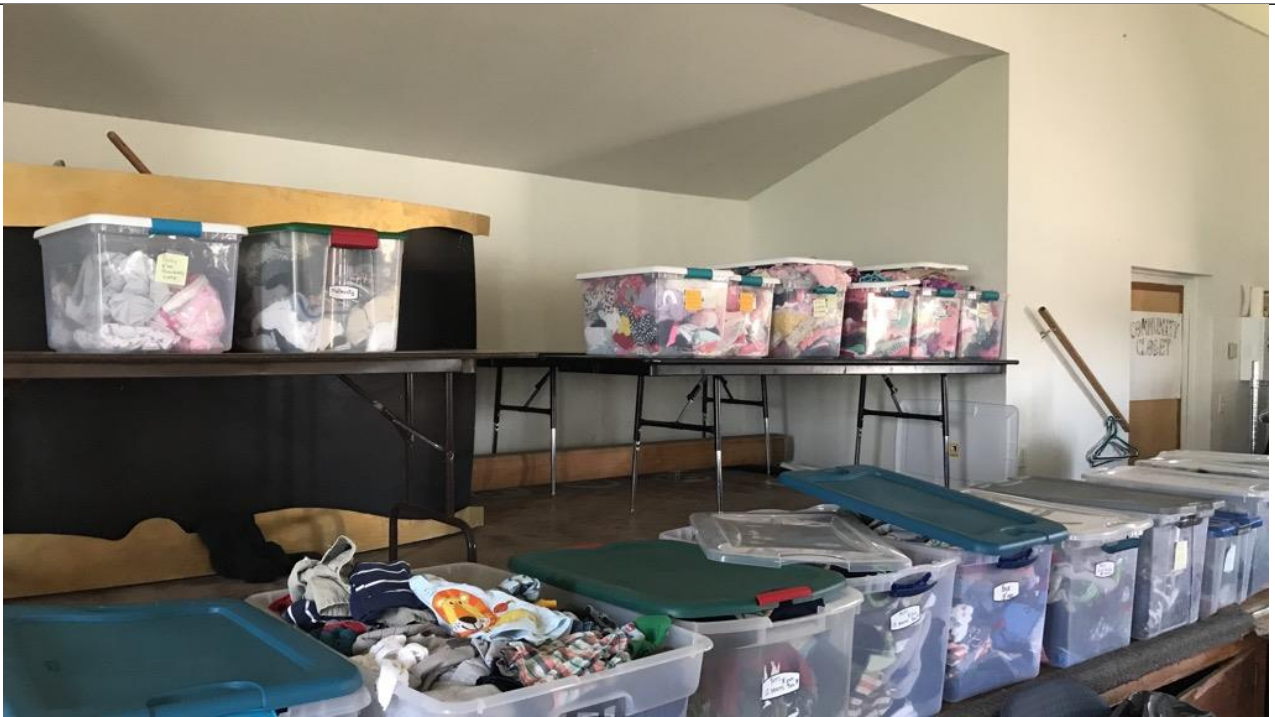
STAGE / RAISED PLATFORM – NO ADA ACCESS

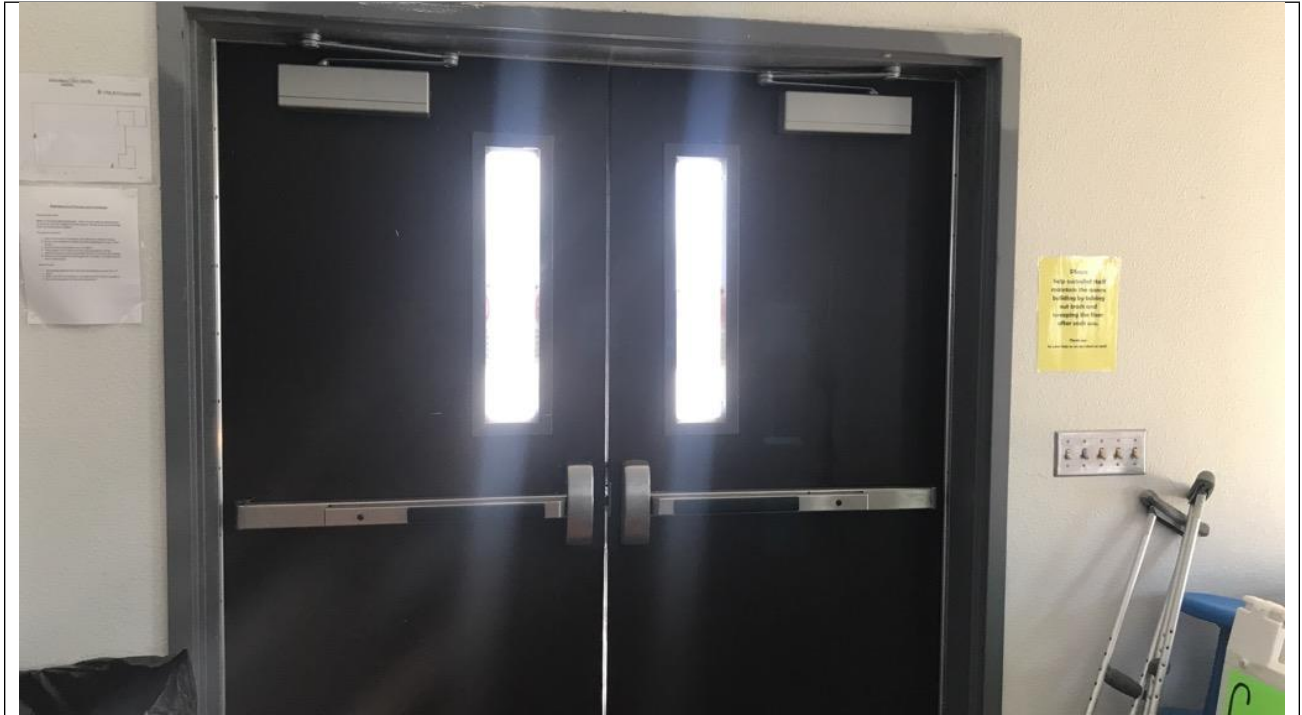
MAIN ENTRY / EXIT DOORS MEET ADA REQUIREMENTS
