FACILITIES ASSESSMENT AND GROWTH PROJECTION REPORT

Horseshoe Bend

School District No. 73

Horseshoe Bend, Idaho
September 21, 2021

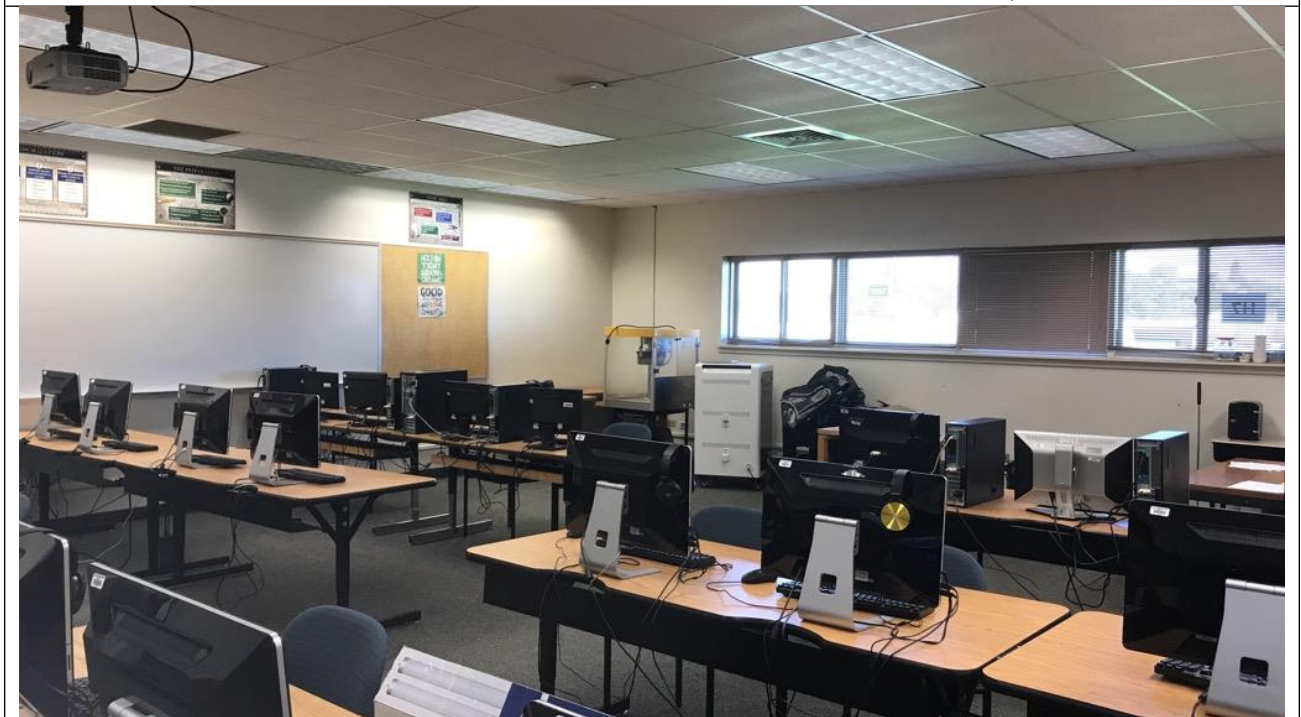
COMPUTER CLASSROOM / PROJECTOR TECHNOLOGY

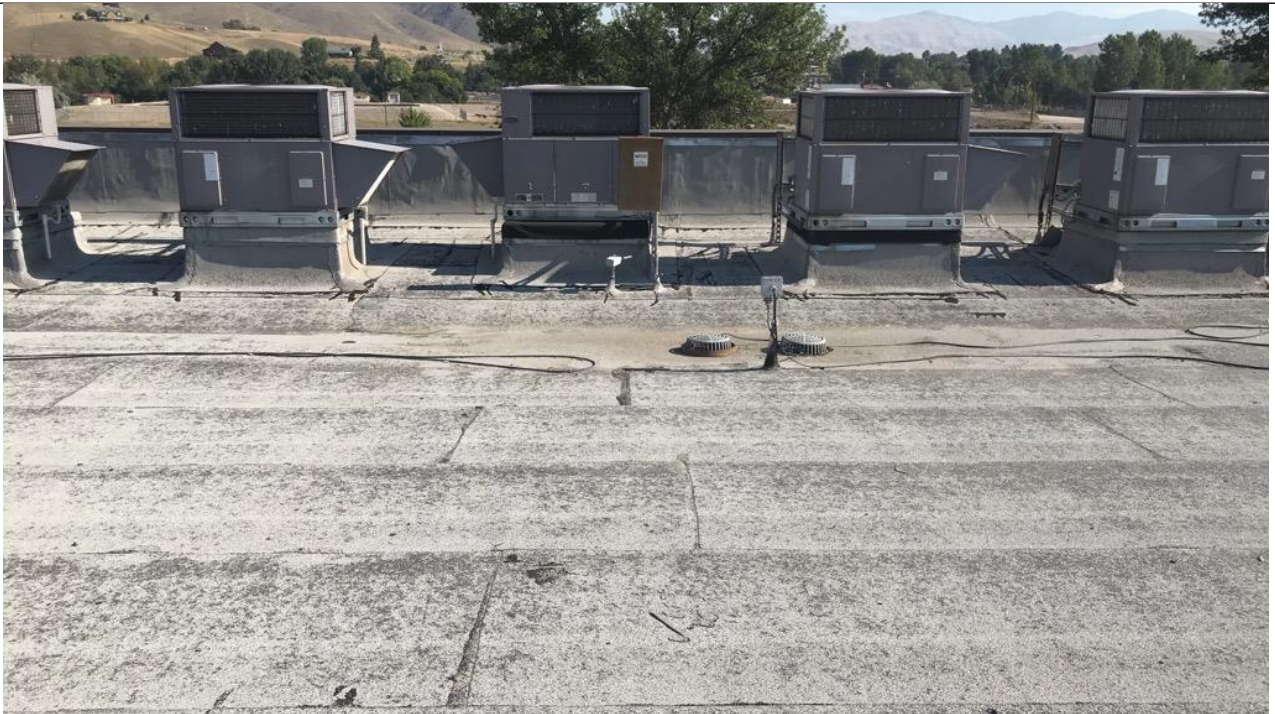
BUILT UP ROOFING SYSTEM AND ROOF TOP MOUNTED MECHANICAL UNITS

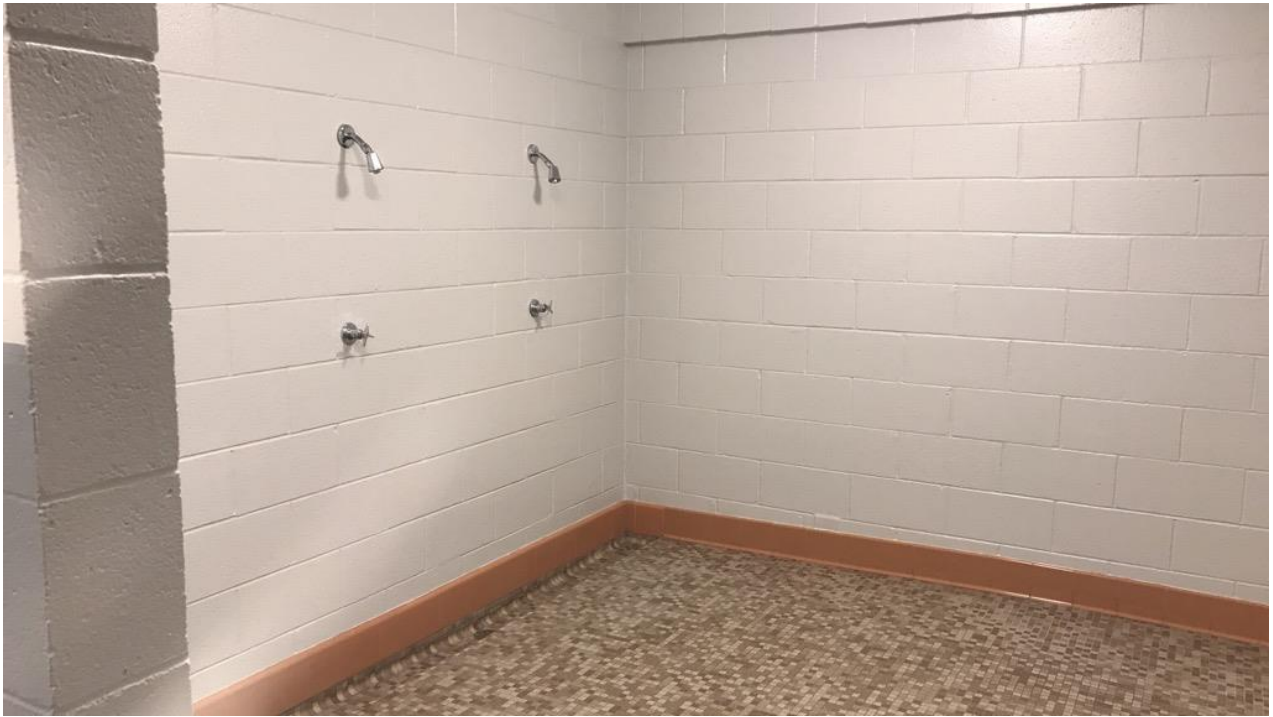
SHOWER AREA

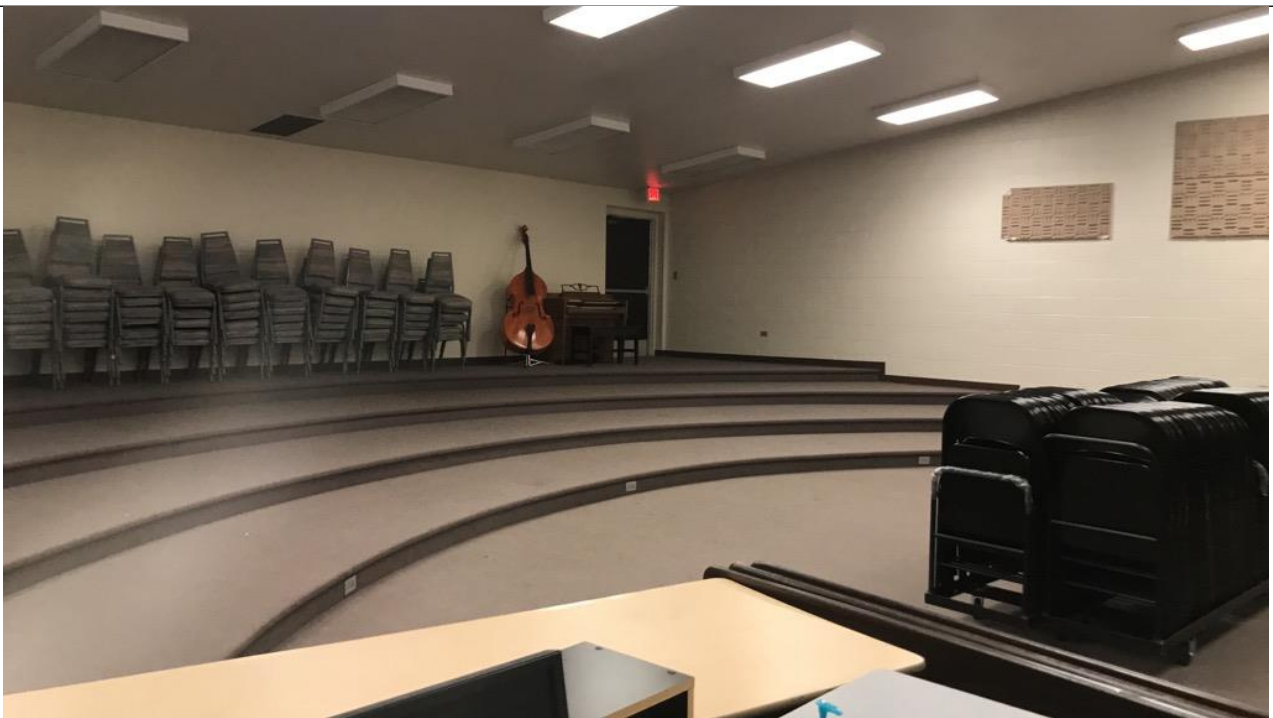
MUSIC ROOM / BUILT IN RISERS

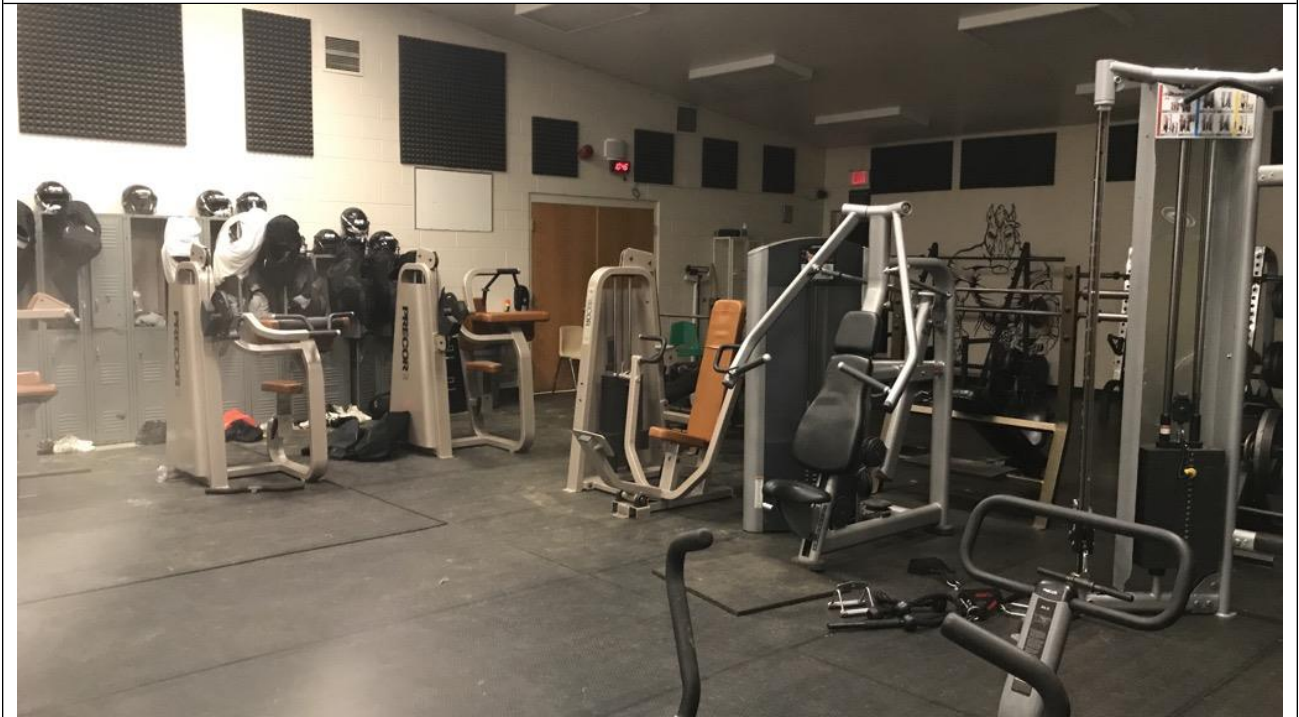
WEIGHT ROOM

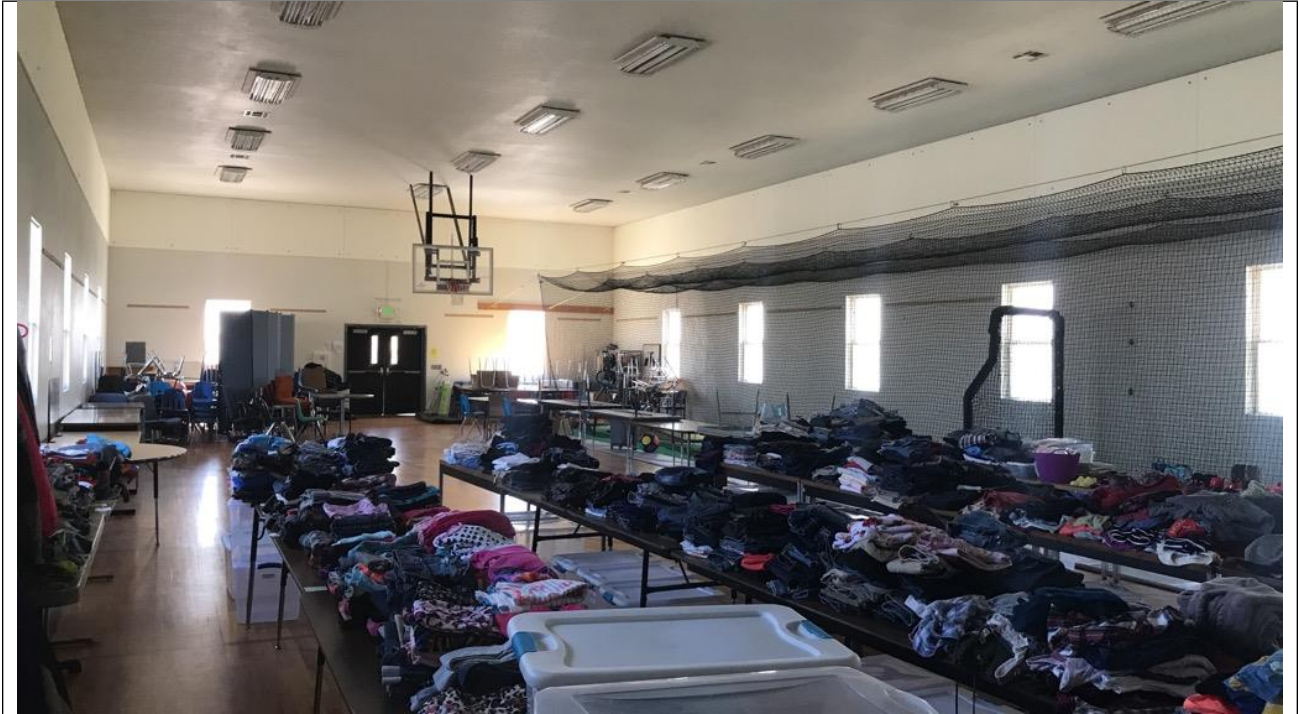
MULTI-PURPOSE ROOM

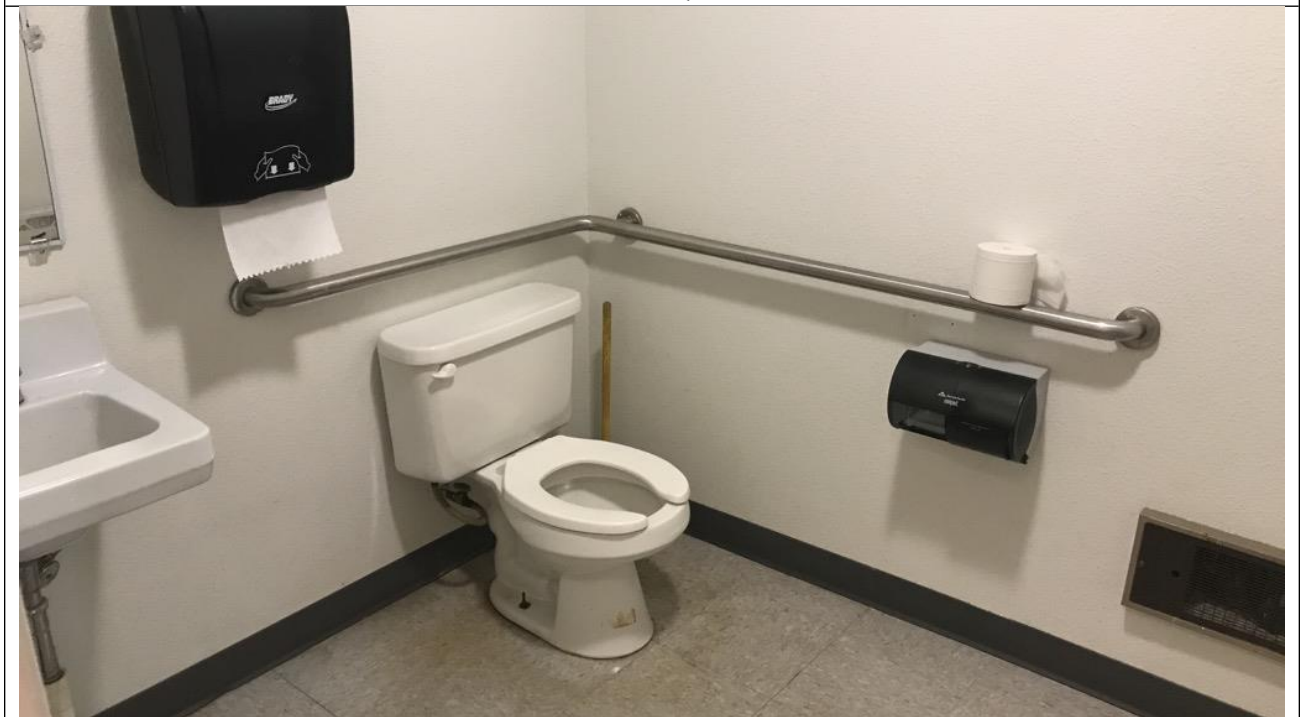
ACCESSIBLE RESTROOM
